Vision Front Fender Extension “Flare”

Service Update #20-0122

Front Fender Extensions Are “FLARING OUT” At The Bottom

Service Instruction “SI-65-300-901 Vision Front Fender Trim”

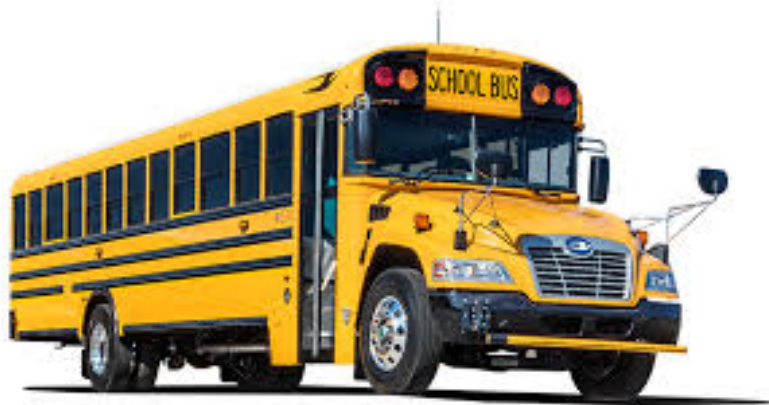
It has been found that the front fender extensions on earlier model Vision units over time will tend to “flare” out at the bottom just behind the front tire. This has been addressed in production with the implementation of a fender extension that has a slight radius.

Blue Bird has issued “Service Instruction #SI-65-300-901” to address units in the field. This Service Instruction along with the template is attached for your use should you decide you have a vehicle where the flare is excessive.
