DEF Head Replacement Information-Fault Code #1679

Service Update #20-0305

New DEF Head May Not Actually Be Bad There are Conditions That May Need To Be Met Before You Condemn a New DEF Head

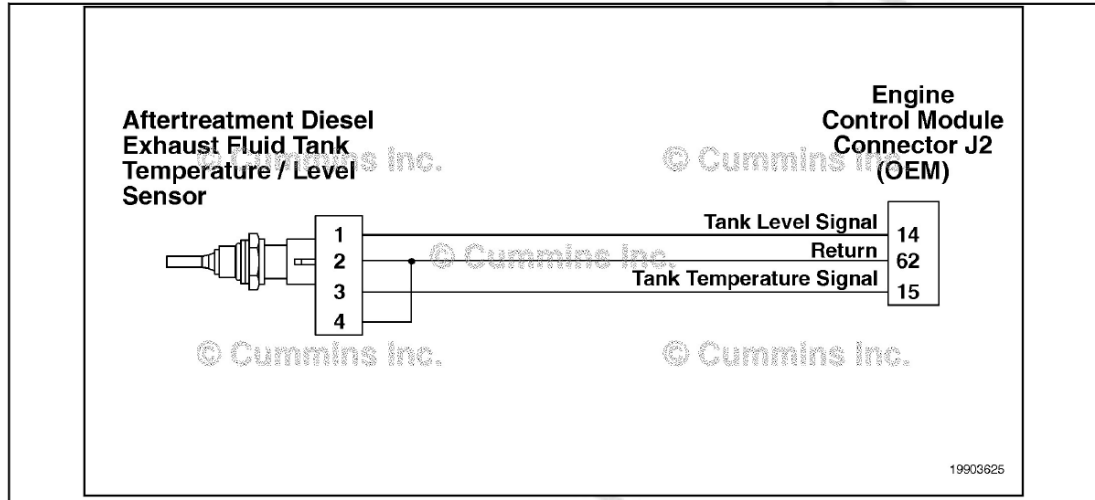
Aftertreatment Diesel Exhaust Fluid Tank Temperature Sensor Circuit

In-range failure of the diesel exhaust fluid tank temperature sensor
Damaged wiring harness
