Water in Fuel Display on Blue Bird Vision Tech Tip #19-1207

There is a "Water in Fuel" Message on the INFO Center of the Dash

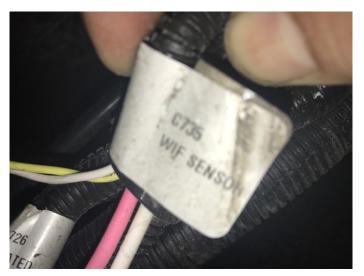
FIGURE #1

We continued to investigate.....several years ago we had standardized to use option #40233-14 which changes location of the fuel/water separator mounting from being mounted on the frame over the rear axle to being mounted on the Driver Control Module (Firewall). The electrical harness is the same for both applications and when this option is ordered we recommend to install a plastic "cap" over the connector plug #C735 at the rear to prevent water infiltration. Please see Figures #1-#3

Once you determine this to be an issue, clean the connector on the unit and verify by clearing the code that the issue has been resolved.
