Vision Shifter w/Ford Trans

Tech Tip #19-0601

SHIFTER
PART #10035807

SHIFTER WILL NOT EASILY SHIFT BETWEEN GEARS

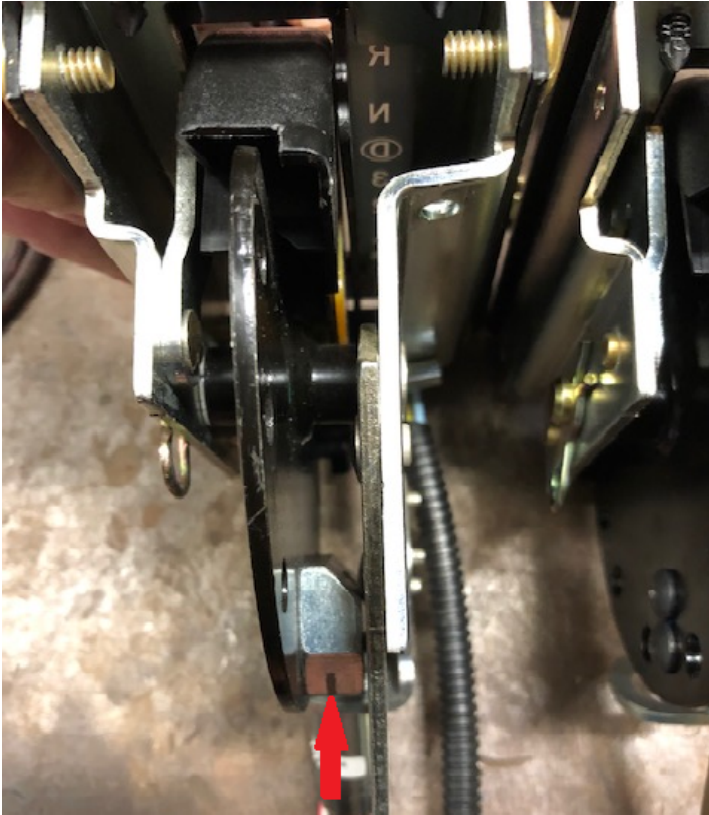
FIGURE #1

Figure #1 shows a side shot of the shifter and the solenoid block we are speaking about is shown by the read arrow toward the bottom of the figure. The block is bolted to the shift handle on the right (black plate) and if you look closely at the gold plate on the

right, you will see that block rubbing against a rivet and once the block is removed (Figure #2) you can clearly see where the rivet had run against the block below the lower mounting hole.

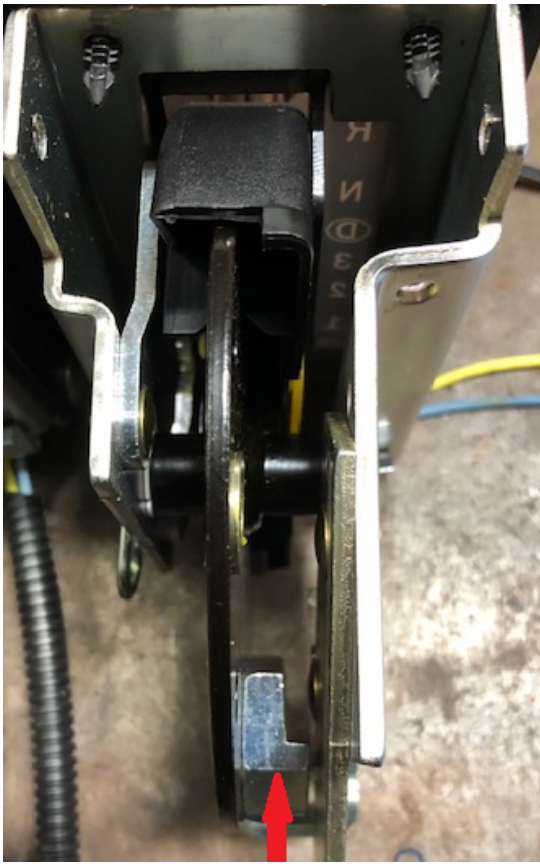
FIGURE #3

We ordered a new shifter for the unit to compare with what we were seeing and it was quite evident that there was a change in the design of the block to address the issue with the new shifter as seen in Figure #3.

Seeing as the part number for the shifter has not changed, we are trying to find out the date code of when the change in the block was implemented and also if just the updated block and screws could be provided separately.

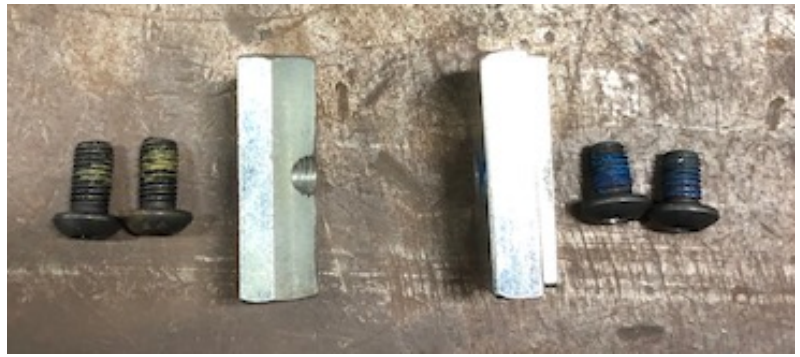
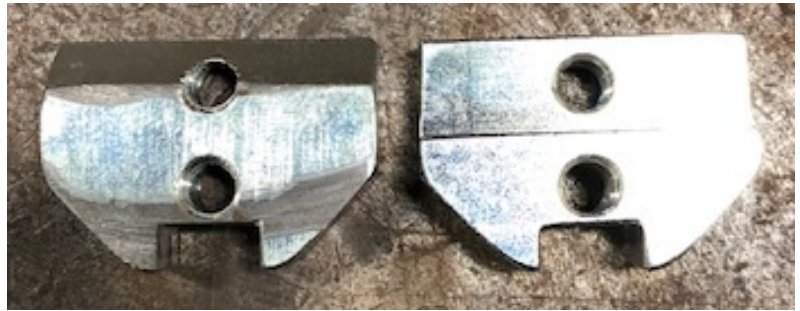
The blocks are mounted to the shift selector handle with 2 allen-head screws so we removed them to compare the blocks and as you can see the new blocks are slightly thinner and a larger portion of the new block has been removed for added clearance. This can also be seen in the length of the screws as the new screws are shorter so they don't protrude through the new block.

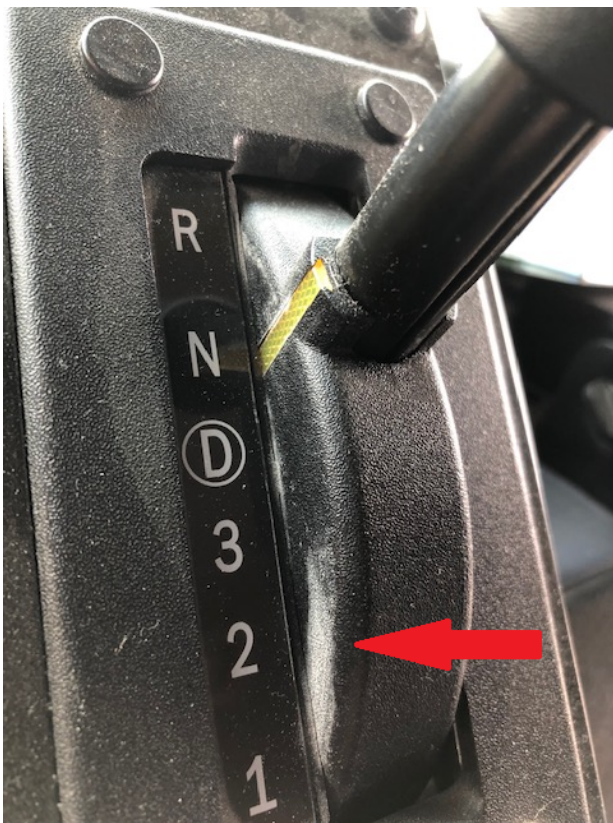
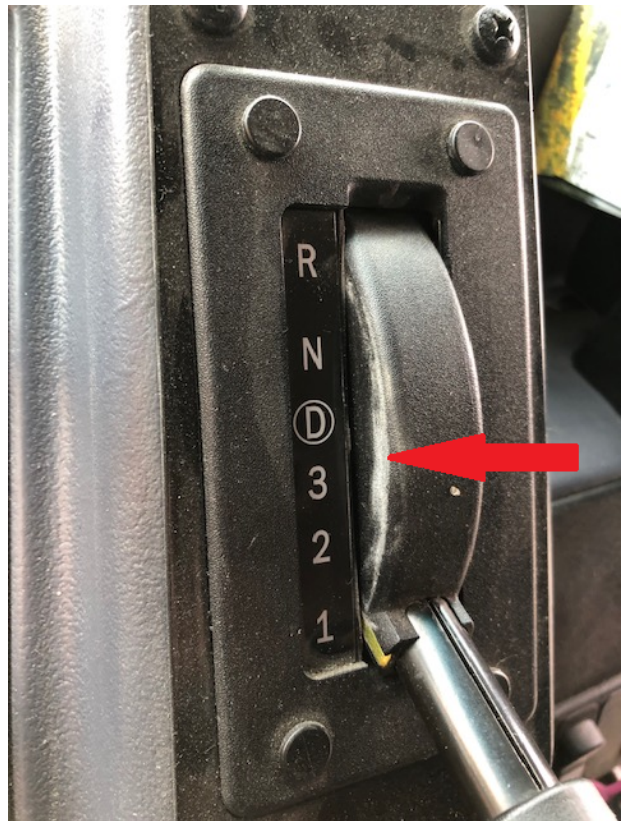
The other telltale sign which we found was that on the shift selector you could see actual marks on the base of the handle where it had rubbed as seen in Figure #6 & #7.
