"Next Gen" Black Seat Belt SERVICE NOTICE #18-0807

Issue with Possible Seat Belt Tripping Hazzard

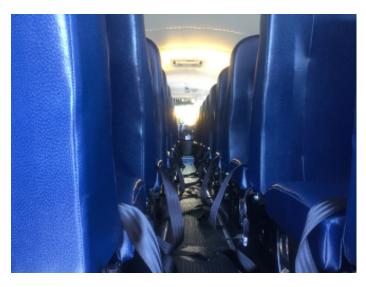
FIGURE 2

Recently it was brought to our attention that there was a possible issue with the black seat belt (Outside Seated Position) where when extended and latched the belt could "flop" into the aisle and cause a tripping hazard (See Figures #1 & #2).
