Micro Bird Recall #21-087-DUS Service Update #21-1023

Addressing Micro Bird Recall #21-087-DUS

IMPORTANT SAFETY RECALL NOTICE – 21V530

TITLE: A - Service Door Adjustment

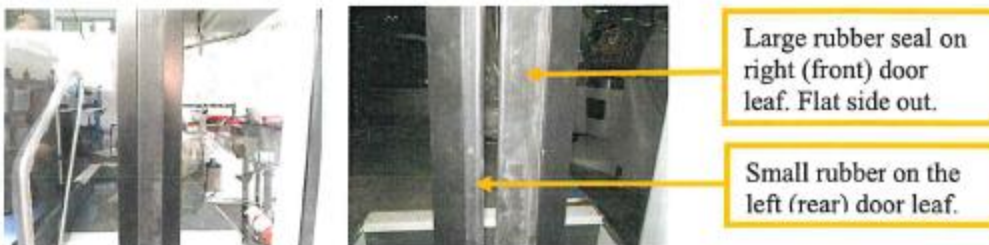
Step 1: While standing outside the bus, make sure the service door rubber seals are installed correctly as shown on these pictures.

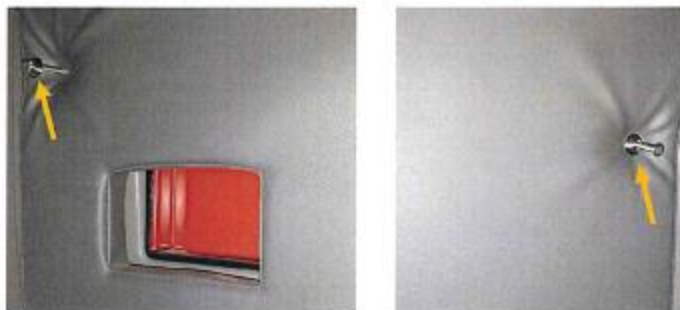
Step 2: Carefully remove the head pad above the service door. Make sure to safely keep the removed cover caps and screws since you will need them to reinstall the head pad.

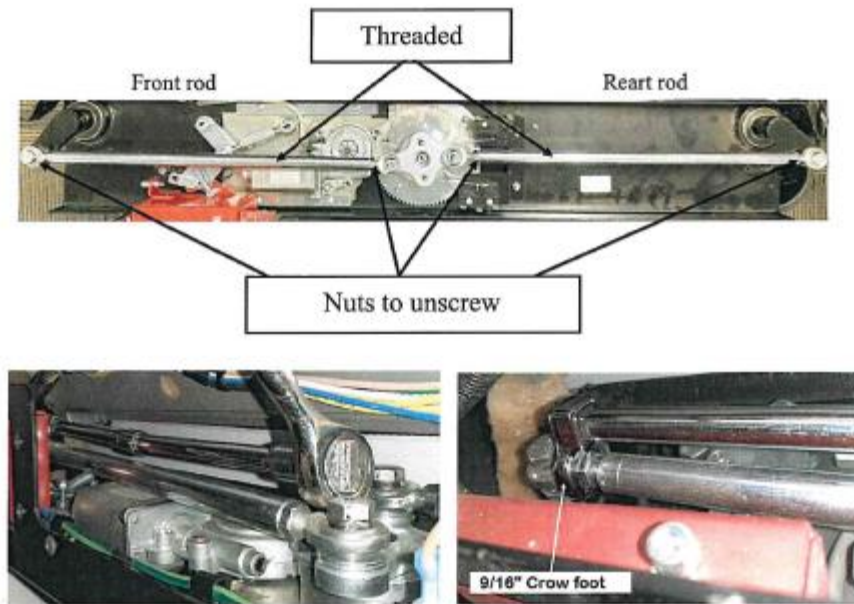
2. Unscrew the nuts at the end of each rod. You could use the crowfoot wrench extension.

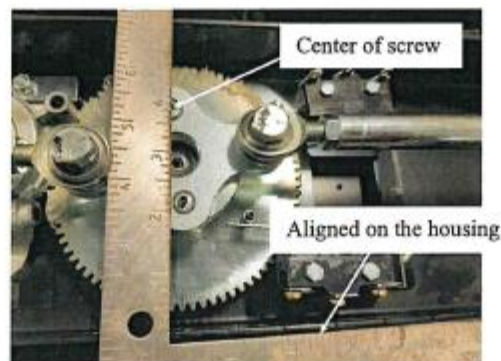
3. Give the front treaded rod eight (8) full turns clockwise (toward you) and four (4) for the rear one. The door should normally open a little more.
4. Engage the service door emergency release, and then open and close the service door using the console switch.
5. Press one side of the square along the inside of the cabinet. Align the other end with the center of the top pivot screw (located nearest the outside wall of the bus) as shown below.

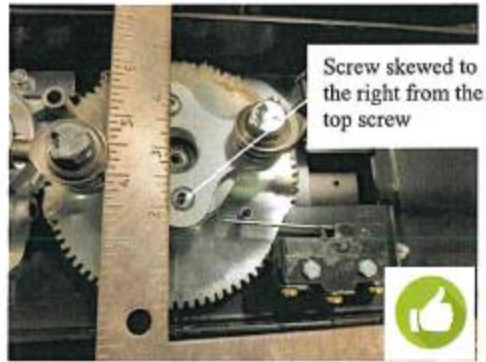
6. If the pivot is oriented correctly, the bottom screw is slightly skewed to the right (Figure 3.2).

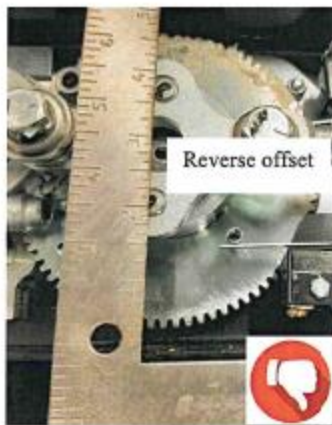
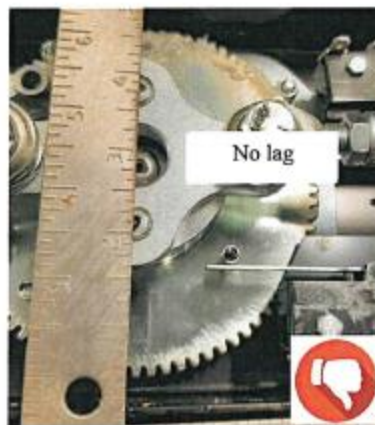
The following figures illustrate situations where the pivot is not oriented properly.

1. Make sure that the door panels do not touch the doorstep. If the door is still pressing the frame, give some more clockwise turns (toward you) on both rods. Verify and repeat in case there is still contact between a door panel and the steps.
2. Open and close the door using the console switch. Verify the orientation of pivot as per Step 3.
3. If the pivot is not oriented correctly, hold the tab and bend its end slightly away from you as shown below.

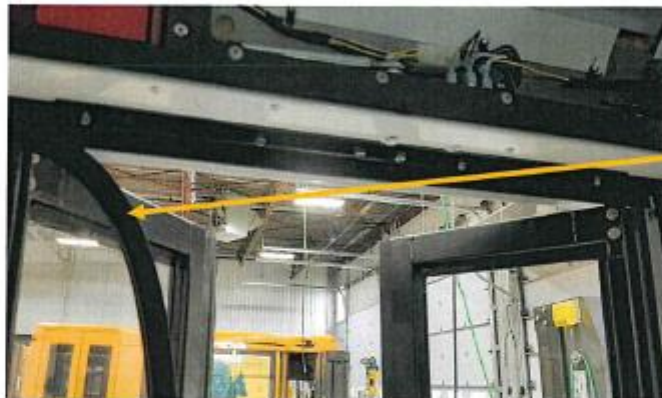
Upper seal

1. With the door opened, pull out one end of the upper seal to completely free the center of the top doorframe, as shown on next picture. Be careful, the upper seal is fixed with sealant at both ends.

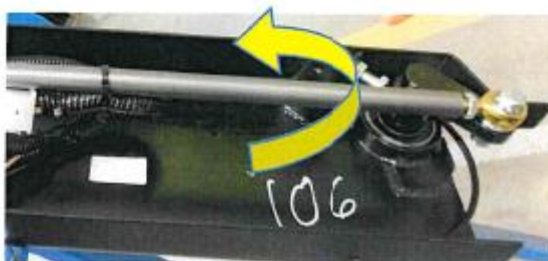
Jeu 3/16 po

2. Use the console switch to close the door. Make sure that the door panels do not touch the doorstep. If the door is still pressing the frame, give some more clockwise turns (toward you) on both rods, making sure that they have received the same number of turns. Verify and repeat in case there is still contact.
3. With the door closed, start adjusting the rear door panel by turning the rear rod outward (away from you) until the top of the panel is $3/16$ inches from the top frame. You could use a $3/16$ in shim to help or measure regularly using a ruler. It might help to use vise grip pliers to turn the rod.

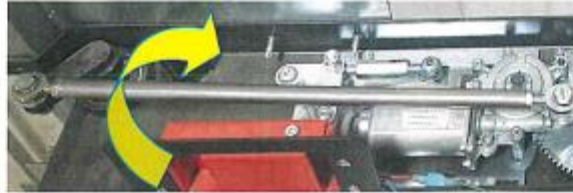
4. Open the door using the control switch and reinstall the upper seal.
5. Close the door using the control switch.
6. Proceed with the front rod, using pliers to rotate. Turn it outward (away from you) until the top of the front panel rubber seal touches firmly the rubber seal of the rear panel until there is no visible gap between the two panels rubber seals.

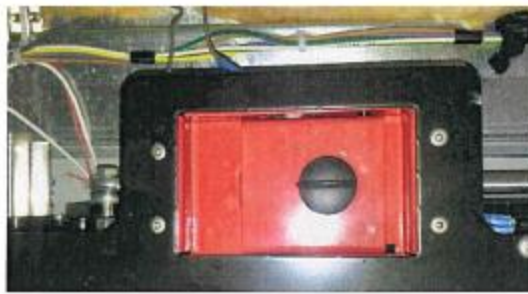
Warning: If the vehicle is equipped with an outside service door emergency handle (Option EDER), make sure that the lock (Option I70 - INTERLOCK DOD ELECT W/EXT HAND/REL) is deactivated (see picture below for reference) before testing the service door handle.

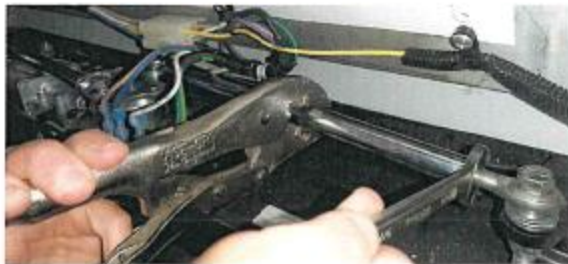
1. Make sure the service door emergency release is in the closed position and close the doors with the console switch.
2. Tighten the lock nuts at the end of the rods, retaining the rod with the pliers so they do not turn. Once the lock nut is in contact with the rods, give an additional 1/4 turn.

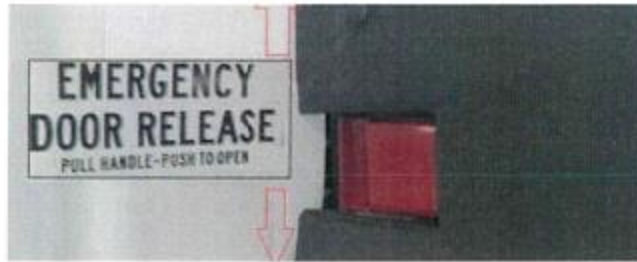
Step 1: Ensure that the service door is closed and that the emergency handle over the service door is in the closed position.

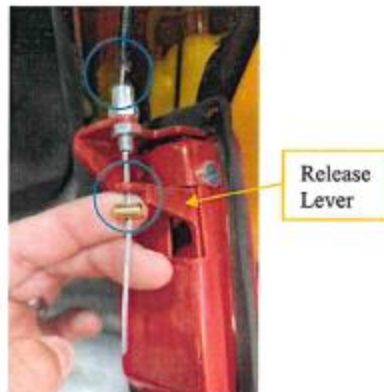
- Delicately pull the cable using the pliers to eliminate slack on the cable, but without tautening it.

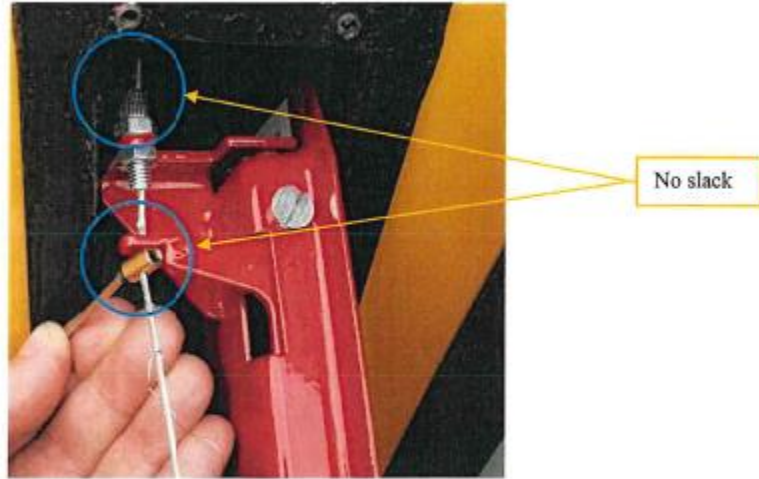
- Slack the set screw on the brass stopper to help push the stopper close to the handle lever

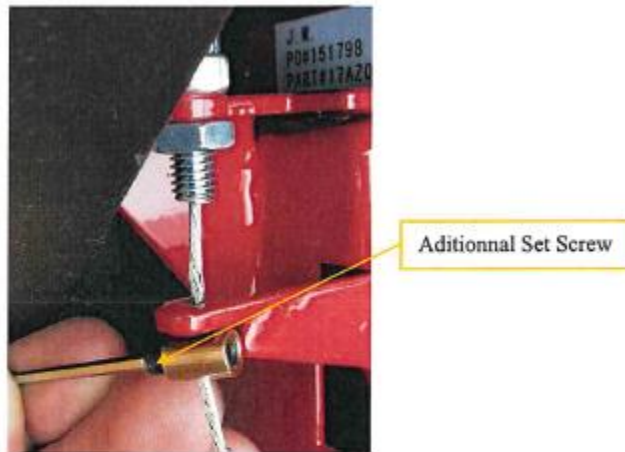
Step 4: Insert the M4 Set screw in the brass stopper and tighten the set screw on each end using the 2mm Hex Drive.

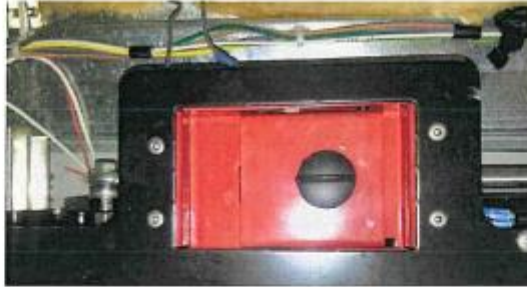
Warning: If the vehicle is equipped with an outside service door emergency handle (Option EDER), before testing the service door handle, please make sure that the lock (Option I70 - INTERLOCK DOD ELECT W/EXT HAND/REL) is deactivated (see picture below for reference)
