Supply Module Relay Failure – Water Intrusion on BBCV/Vision Tech Tip #18-0423

Water Intrusion – Supply Module Relay

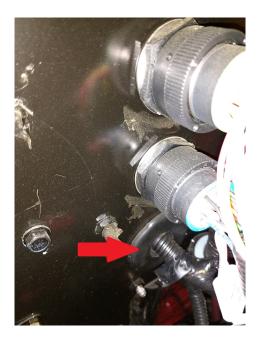
FIGURE #1

We have seen instances where there will be a MIL or CEL and checking has found that the code thrown is for accelerator pedal voltage or erratic data. Some of the codes have been 1239, 1241, 1242, 1515. After diagnosing the issue, it was discovered that the "Supply Module Relay" had failed and once removed corrosion can be seen in the holder (FIGURE #1).

Upon further investigation we learned that there is a rubber grommet located in the center of the firewall with a loomed harness passing through it (FIGURES #2 & #3). The grommet is located below the 2 bulkhead connectors (FIGURE #4) and can be located inside the unit once the PDU cover is removed. Cleaning the connector and relay terminals once the grommet is sealed may allow the MIL/CEL to be cleared, but in some instances the module relay may need to be replaced.
