Water in Fuel Display on Blue Bird Vision

Tech Tip #19-1207

There is a “Water in Fuel” Message on the INFO Center of the Dash

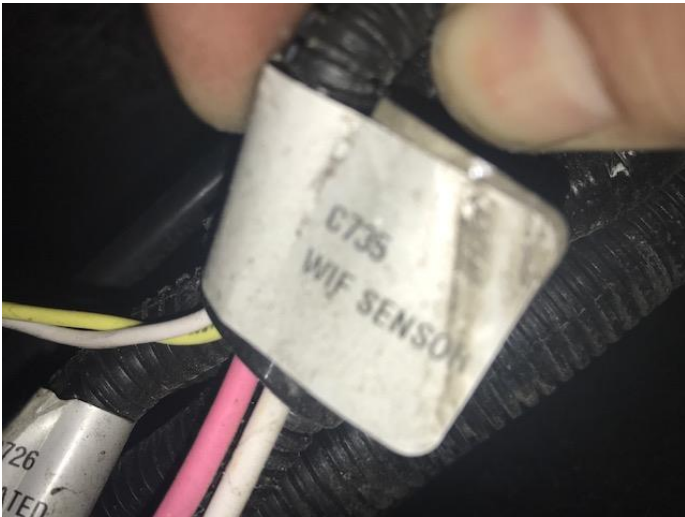
FIGURE #1

We continued to investigate... several years ago we had standardized to use option #40233-14 which changes location of the fuel/water separator mounting from being mounted on the frame over the rear axle to being mounted on the Driver Control Module (Firewall). The electrical harness is the same for both applications and when this option is ordered we recommend to install a plastic “cap” over the connector plug #C735 at the rear to prevent water infiltration. Please see Figures #1-#3

Once you determine this to be an issue, clean the connector on the unit and verify by clearing the code that the issue has been resolved.
