## Blue Bird Vision/Ford Transmission Tail Shaft Mount Tech Tip #17-0706-RP

## **Transmission Tail Shaft Mount Issue**

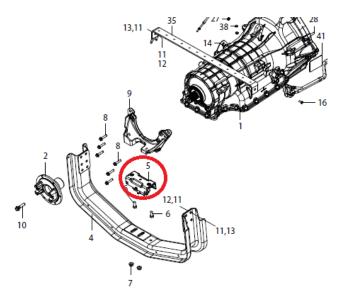
It's come to our attention that there are units experiencing a "thumping" noise when shifting. The rear mount (BB Part #10043517) for the tail shaft, circled in red on the drawing above and shown in Figure #1, had become worn causing the issue. A simple check can be done using a pry bar, as illustrated in Figure #2. There should be "slight" (About 1/8" to ½") of play. What was found on units where the issue occurred was that the cross bolt was rubbing into the metal (Figures #3 & 4). Removing the cross bolt and putting a piece of rubber hose over the shaft of the bolt between the metal will address the issue temporarily until a new mount can be ordered and replaced.
