Cummins Technical Service Bulletin

TSB140104

Misdiagnosed Oil Leak at Flywheel Housing

Rust Preventative Oil at Flywheel Housing Misdiagnosed as Rear Crankshaft Seal or Crankshaft Collar Malfunction

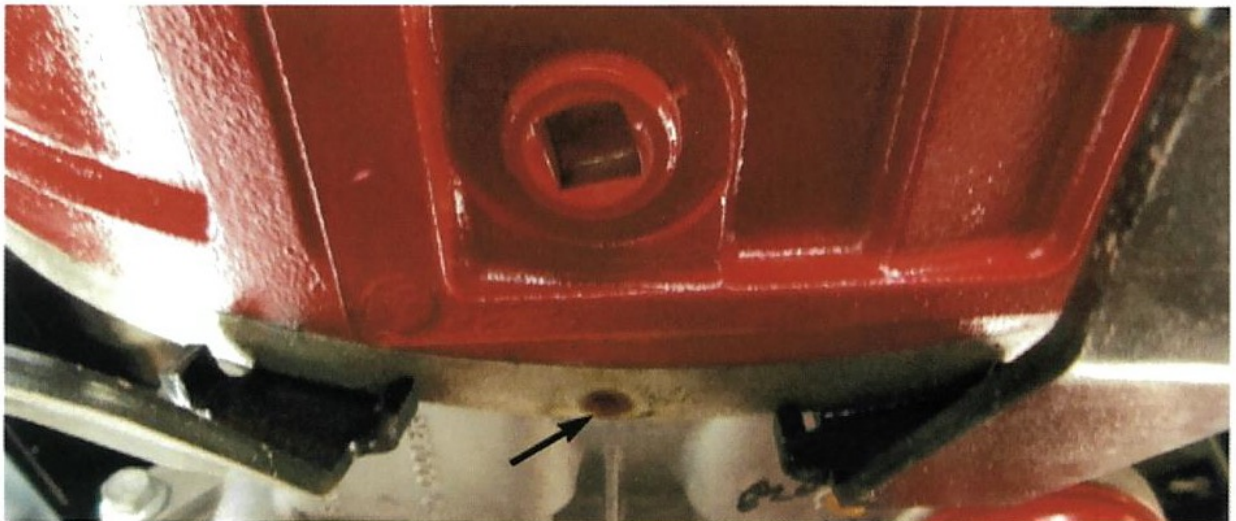
Residual rust preventative oil from manufacturing can be present at the rear of the engine and be incorrectly diagnosed as a rear crankshaft seal malfunction or a crankshaft collar malfunction on rear gear train engines.

During engine assembly, rust preventative oil is applied to the inside of the flywheel housing. Excess rust preventative oil droplets can be visible on the outside of the transmission or flywheel housing, similar to what is shown in Figure 1 below. The use of tracer dye, Part Number 3376891 or 2892320, is **not** effective in identifying the leak path, as the preservative oil also has a fluorescent property.

Figure 1, Example of Rust Preventative Oil at the Flywheel Housing Area

- Clean external surfaces of all oil around the suspect area.
- Remove the plug in the bottom of the flywheel housing.
- Spray electrical contact cleaner, Part Number 3824510, or equivalent, into the flywheel housing.
- Wipe surfaces clean.
- Operate the engine for at least one hour at idle and monitor for leaks.

- If oil is **not** present after performing the Verification steps above, no further action is required.
- If lubricating oil is present, refer to published troubleshooting for lubricating oil consumption excessive in the corresponding Service Manual.
