Tech Tip

From your friends at New York Bus Sales

Product Effected – D3 and BBCV w/Actia Dash Cluster

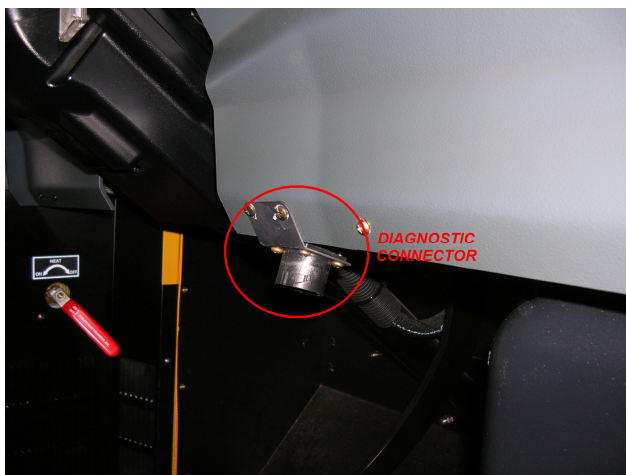
FIGURE #1

Step #1 – Turn the ignition off. Locate the diagnostic plug at the right side of the steering column at the bottom of the dash (FIGURE #1)

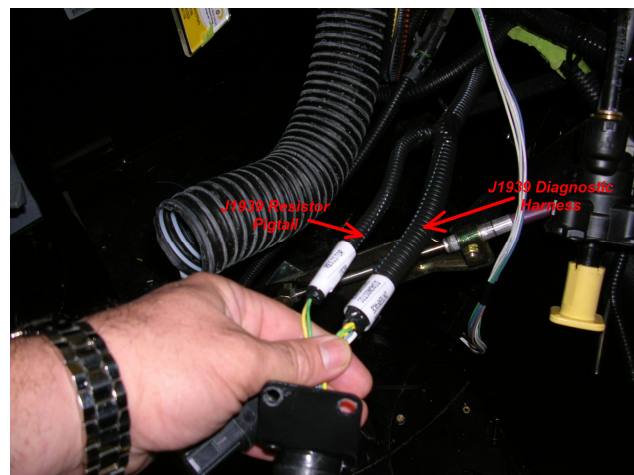
FIGURE #2

Step #2 – Follow the harness back approximately 8” to 10” and locate the pigtail off the harness (FIGURE #2)

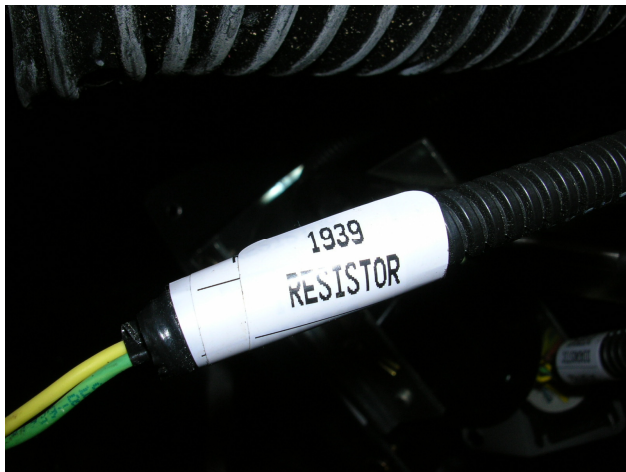
FIGURE #3

Step #3 – Remove the pigtail from in under the dash and verify you have the proper pigtail by identifying by the tag at the end(Figure #3)

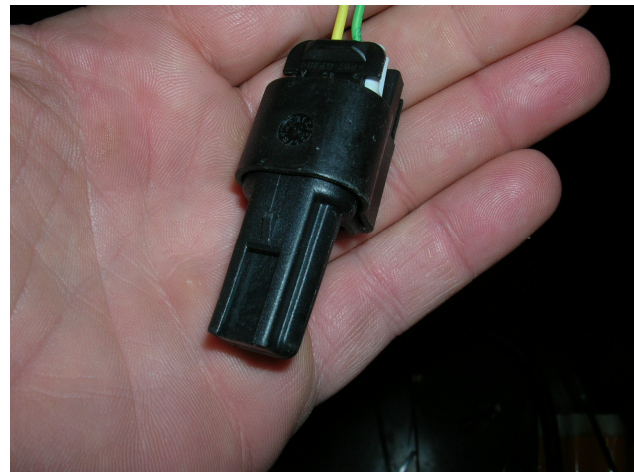
FIGURE #4

Step #4 – Locate the terminal and resistor at the end of the pigtail (Figure #4)

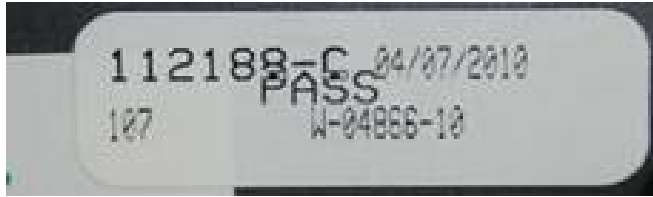
PLEASE NOTE: Where as the clusters need to be returned for warranty thru normal channels, information off the tag (PICTURED BELOW) on the cluster should be reported to:
