Tech Tip

Product Effected – 2006 Thru 2008 BBCV (Vision)

Hendrickson Tie Rod Ends

S07MC
SERVICE BULLETIN

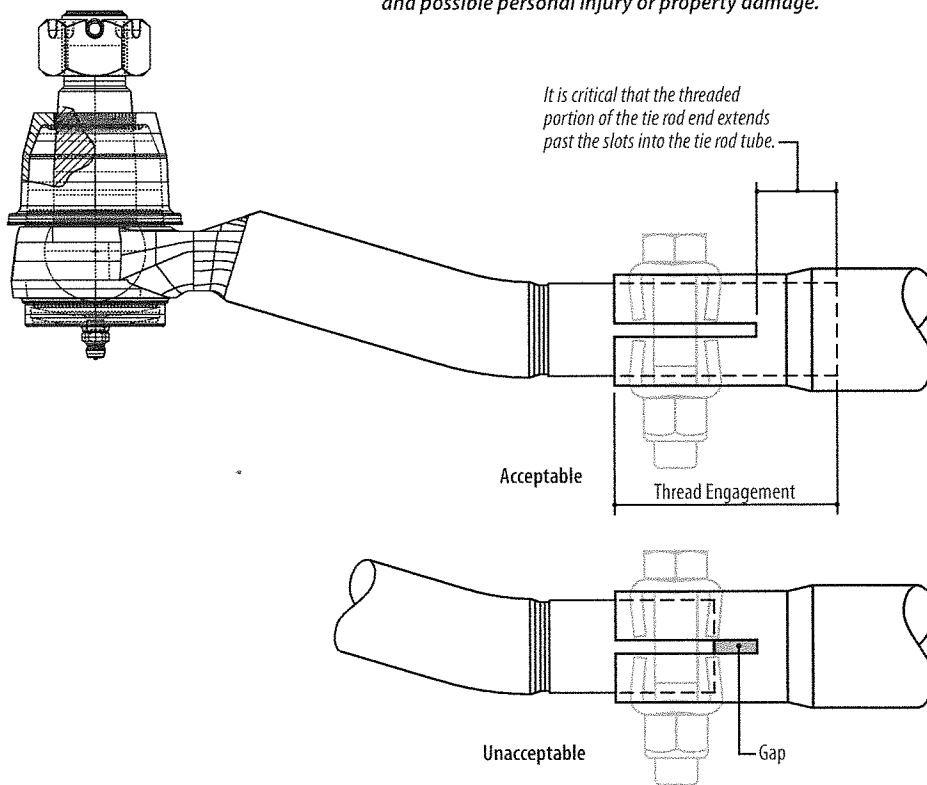
Inspect all Tie Rod Ends and/or Tie Rod End/Cross Tube assemblies, installed or purchased since July 2005. Inspect tie rod end thread engagement into cross tube. If threads do not extend past the end of the slot in the cross tube or if any gap exist between the tie rod end and the end of the cross tube slot, contact your Blue Bird Service Parts Representative for replacement parts.

WARNING: The threaded portion of the tie rod end must extend past the slots in the tie rod cross tube, failure to do so can cause component to fail causing loss of vehicle control and possible personal injury or property damage.

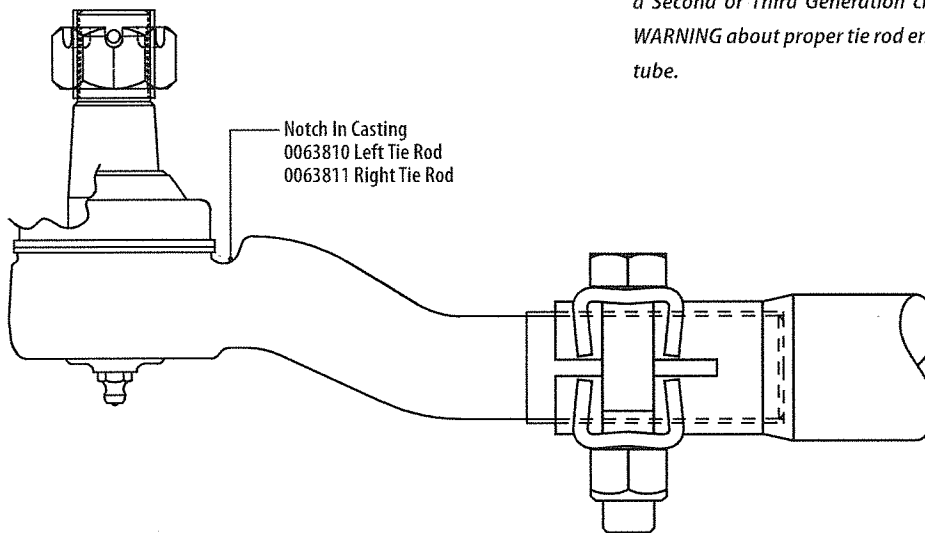
First Generation Tie Rod Ends

First generation tie rod ends were used on Blue Bird Visions from its launch date to mid July, 2005. This tie rod end can be identified by a "notch" in the casting very near the rubber bushing. The replacement part numbers for this style tie rod end are 0063810 (Left) and 0063811 (Right).

Per Hendrickson Technical Bulletin SEU-0223 Tie Rod End Replacement Kits Revision B dated May 2007, the tie rod assembly and tie rod ends for these parts are obsolete and are no longer available. The entire tie rod assembly must be replaced. Per Hendrickson Technical Bulletin, Hendrickson Tie Rod End part number 66699-001 (Blue Bird 0094365) replaces Hendrickson Tie Rod End part number 59948-001, 59948-002 or 59948-006. Per Hendrickson Technical Bulletin, Hendrickson Tie Rod End part number 66699-003 (Blue Bird 0118467) replaces Hendrickson Tie Rod End part number 59948-004 or 59948-005. Note: The tie rod part number is located on the tie rod cross tube. Select the correct replacement for your vehicle.

WARNING DO NOT use a First Generation tie rod end with a Second or Third Generation cross tube. Refer to Hendrickson WARNING about proper tie rod end thread engagement into cross tube.

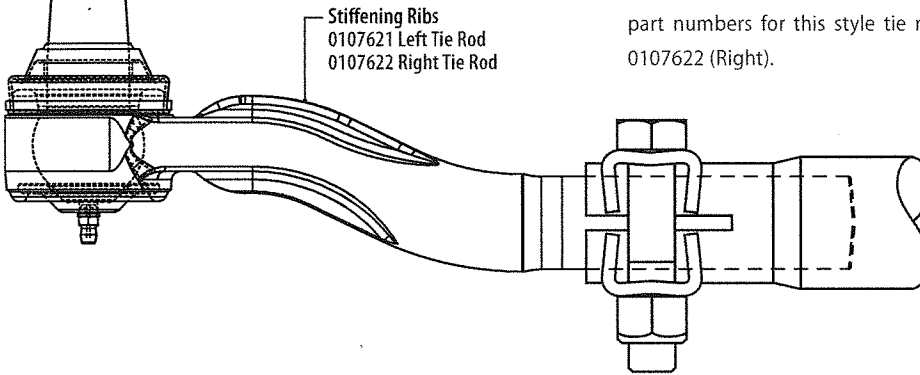
Second Generation Tie Rod Ends

Second generation tie rod ends were used on Blue Bird Visions from mid July, 2005 to July, 2006. This tie rod end can be identified by stiffening ribs on the top and bottom of the casting between the threads and the rubber bushing. The Blue Bird replacement part numbers for this style tie rod end are 0107621 (Left) and 0107622 (Right).

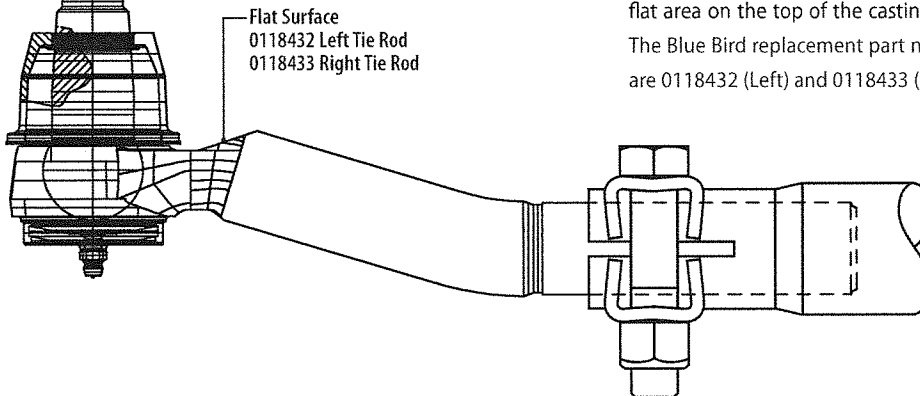
Third Generation Tie Rod Ends

Third generation tie rod ends were used on Blue Bird Visions from July, 2006 to present date. This tie rod end can be identified by a flat area on the top of the casting very near the rubber bushing. The Blue Bird replacement part numbers for this style tie rod end are 0118432 (Left) and 0118433 (Right).

The tie rod ends for the Second and Third Generations are interchangeable even though visually they are different shapes and are from different manufacturers.

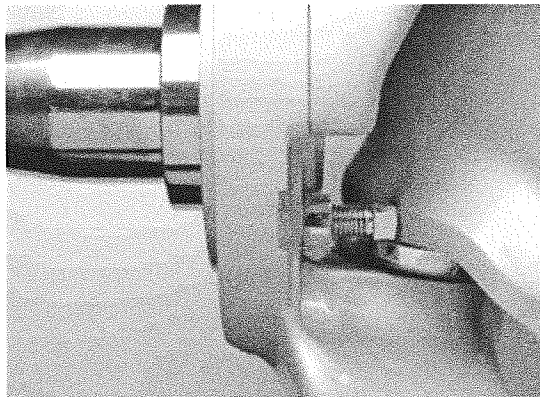
FIGURE 8-18

It is very important that the sides of the square head axle stops are set parallel to the axle beam to ensure a good contact point on the axle, see Figure 8-18.
