GM/MICRO BIRD BATTERY CABLE ISSUE

Service Update #21-0513

GM/MICRO BIRD BATTERY CABLE RUBS ON FRAME RAIL

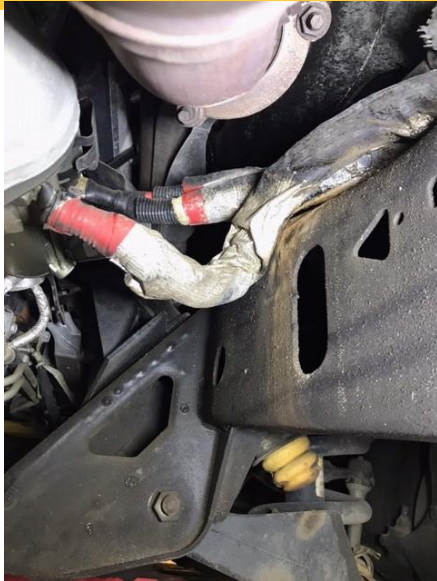
FIGURE #1

It has been found on units equipped with auxiliary batteries mounted in a body mounted battery compartment that the cables feeding power to the starter run over the frame rail have rubbed through the protective sheathing. Initially it was noted by the streaking of the frame as shown in Figure #1 above and once the cables were lifted it was found where the sheathing had worn through as shown in FIGURE #2.

This should be checked during PM service and addressed in a manner to protect or to move above the frame.
