Tech Tip

From your friends at New York Bus Sales

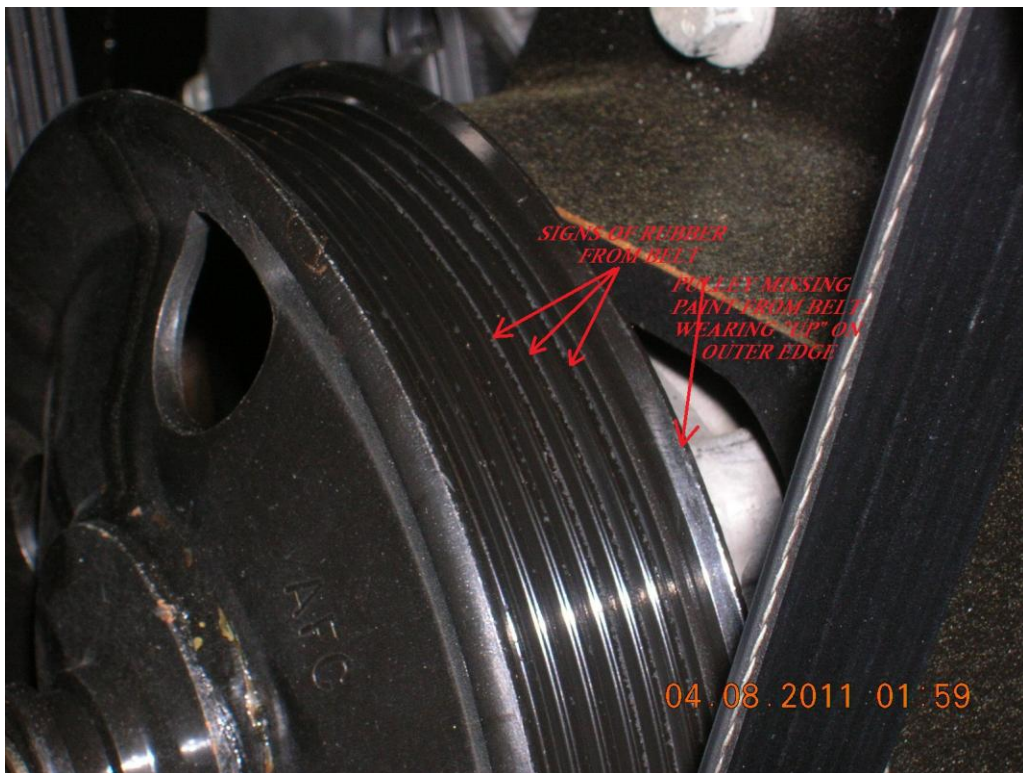
- Complaint -** The belt “squeals” and replacing it only stops the issue for a short time.
- Cause -** Belt misalignment at the power steering pulley
- Correction -** The pulley will need to be pushed onto the shaft about a 1/16”- 1/8” You can determine that this is the issue by inspecting the pulley on the P/S pump and as to do pay special attention to the rear “lips” of the pulley grooves and look for signs of rubber build up as seen in Figure #1 – You may also see where paint is being worn from the inside outer edge of the pulley as shown in Figure #1
If this is the case you can look at the pulley placement on the shaft and you will notice that the shaft is either slightly recessed or just even with the outer pulley edge as shown in Figure #2
GM makes a tool as do the major tool companies for pulling and pushing these pulleys on so using one of those or a bolt, nut and some washers you can fabricate your own “tool” to push the pulley back.
