# P0300 Check Engine Light on 6.8L Ford V-10 Service Update #22-0322

### P0300 — Misfire

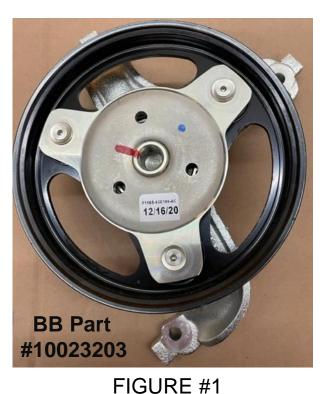
FIGURE #2

The PTO is a pully mounted to a hub in rubber at 3 spots. We have seen those rubber mounts wear causing the pulley to loosen from the hub. When this occurs the PCM detects a false misfire, which can set a P0300 DTC.

After studying several units that were replaced (FIGURE #2) we found that as the rubber bushing wore, the signs of the deterioration were evident on the pulley. Where it did not seem uniform or 100% consistent, there always was evidence of the issue on the ridge of the pulley, sometimes on the outer face of the pulley as in FIGURE #3 and sometimes on the inside right by the bushing as in FIGURE #4. Checking during a PM Service should this be found, replacing the PTO pulley could save downtime.
