From your friends at New York Bus Sales

Product Effected – Blue Bird Type C&D

Complaint - The unit appears to have a fuel leak at the tank -

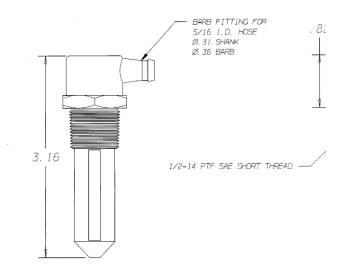
Figure #1

There was a new style vent that was used in production which is pictured in Figure #1, this vent contacts fuel at a lower level than the first production vent which is shown in Figure #2. If you look at the design of the tank, especially those "midmounted" in the frame even if the "first-click" method is used in fueling the tank it will allow the tank to take on more fuel as there is a 2-1/2" fuel fill line from the tank to the fuel fill which needs to be filled with fuel before it will "clock off".

NEW TANK VENT #00066606

Once you are sure this is the location of the leak you should pull the vent and inspect. The "new" style vent should be replaced with the "old" style vent. In changing the vents you are raising the fuel contact point of the vent which if the

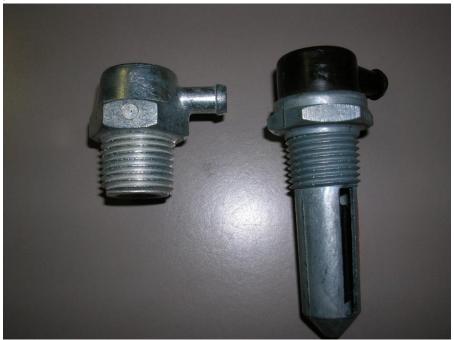
-As you can see in Figure #3 the material make up of the 2 vents is very different.....the old style is a single "cast" piece which is less affected by elements where the new style has potential for corrosion to cause the plastic cap to be forced off the main body as in Figure #4

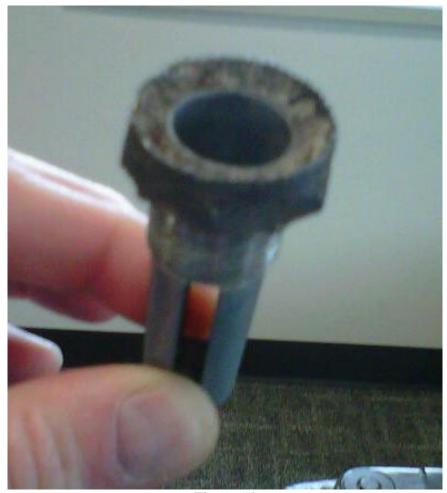
Figure #4

and be ineffective.

When this reaches the #00066606 vent and causes the deterioration where the plastic separates then nearly the whole tank becomes covered in fuel residue and dirt let alone what is allowed to drop into the tank-

Just to avoid any issues it might be recommended that these vents be removed and replaced with the new #10013053!

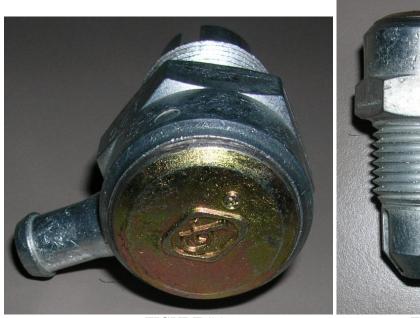
FIGURE #6

UPDATE – April 5, 2011 – BLUE BIRD IS NOW USING PART #10013053...THIS IS AN UPDATED PART AND REPLACES "ALL" PREVIOUS TANK VENTS – IT CAN BE IDENTIFIED BY THE EXTENSION OF THE POT INTO THE TANK AND THE GOLD CAP ON THE TOP AS SHOWN IN FIGURES #5 AND #6
