Tech Tip

BBCV/Cummins Front Exhaust “FOIL” Wrap

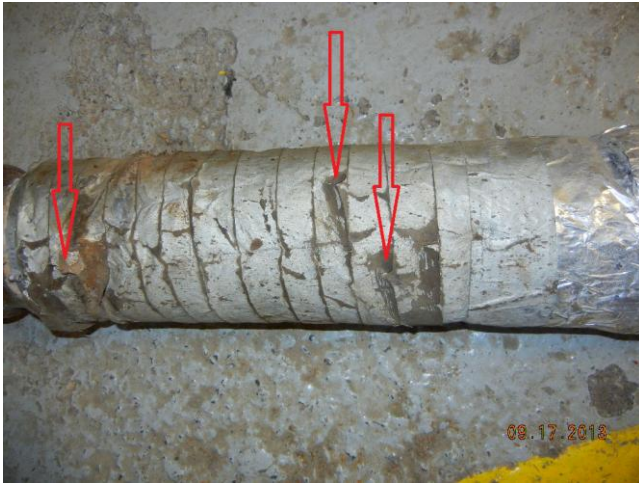
Photo #1

Complaint – There is a tear (Photo #1) in the outer layer of the “foil” insulation.....and if let go long enough can allow the insulation to start to come out (Photo #2)

Cause – There could be several causes, but the shear fact that the pipe runs down close to the front tires where road debris is “kicked” up from the tires lends to the abuse this pipe gets. We have also seen that in some cases it is the way in (direction) in which the tape is wrapped around the pipe and attention should be paid when replacing so that the forward edge is not the “open” end of the wrap.

Correction – Clean all oil/grease debris from the surface of the area which is damaged and completely dry. Then wrap the affected area with the foil wrap tape wrapping at least twice at the beginning wrap and the end wrap to ensure good adhesion.

**Foil Wrap Tape
#10035922**
