Simultaneous Load Seat Plugs

Body Tech Tip #13-0516 Page 1

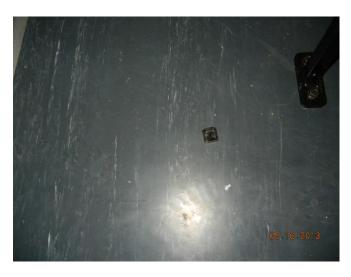
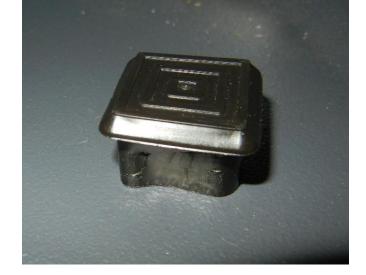
Figure #1 Figure #2

Complaint – There are these small square black plastic pieces that we've found on the floor...see figures #1 & #2

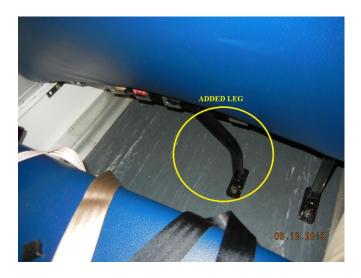
Figure #3

Cause – With the implementation of the new "simultaneous load" seats there was an added "leg" which we spoke about in an earlier Service Notice and that leg is cut and added such that the top of it has an opening which was best dressed with a plastic plug.....see figures #3 & #4
