Tech Tip

FROM YOUR FRIENDS AT
NEW YORK BUS SALES!

Blue Bird BBCV (Vision)/GM 8.1L Propane Engine w/single serpentine belt

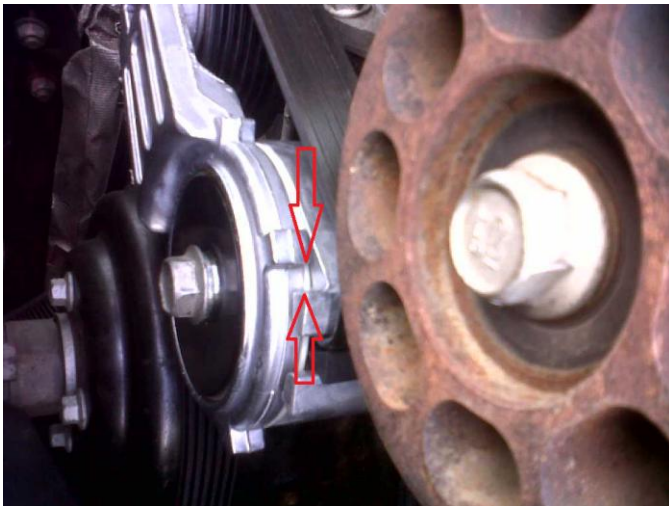
- Complaint –** The belt tensioner nubs are running too close showing that the tensioner +/- or belt are worn. A slight “chirp” may be heard on shutdown of the engine – Please see Figure #1 & 2.
- Cause –** If the belt or the tensioner has recently been replaced it may be the improper part, if not the belt +/- or tensioner may be worn.
- Correction –** If the belt +/- or tensioner have recently been replaced and the “nubs” of the tensioner are still close you need to make sure that the proper parts have been used. See the text box below-

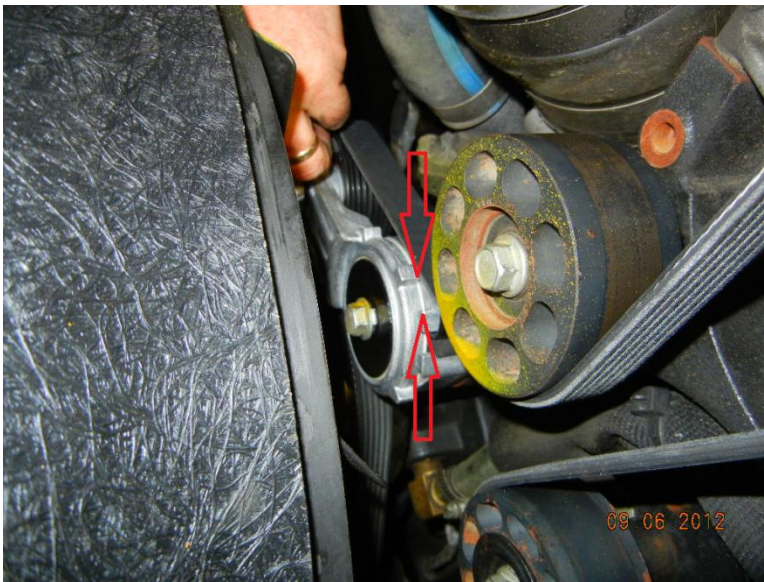
Figure #3

PLEASE NOTE – After checking with Dayco who provided the belt set-up on this unit there should be 14 degrees between the nubs of the tensioner which equates to approximately 1/2” as shown in Figure #3.

PROPER PART NUMBERS

TENSIONER PART #1622-6300-01

BELT-GATES PART #5061360

IDLER PULLEY #6 – DATCO #89106

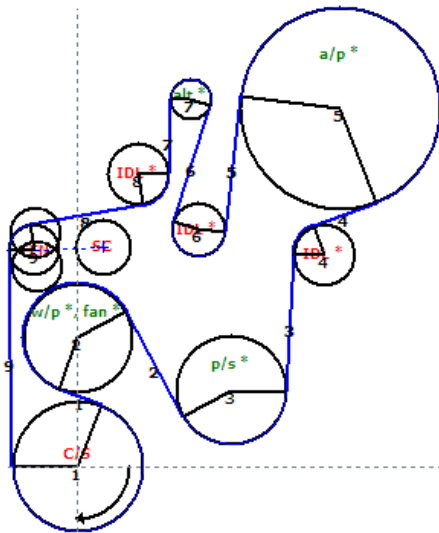
PLEASE NOTE – Figure #4 also gives the proper belt routing-

After replacing the belt and tensioner as previously discussed it was determined that the tensioner would again be running too close to the nubs which was not recommended. Working with Dayco it was determined that idler #6 in the **Figure #4** should be replaced with a slightly larger pulley, Dayco #89106. Once this is done and the unit ran for a couple of days you can see that the tensioner is almost perfectly centered as it should be.
