T3FE Steering Column Boot Clamp

Complaint – Steering seems to have a slight "catch" in it when turning from lock to lock

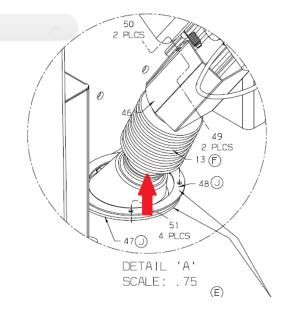
Figure #1 Figure #2

Cause – The "boots" on the lower section of the shaft have a clamp installed which does not allow the steering shaft to turn smoothly and the boot in some cases will rip as the clamp is holding it too tight to the shaft.

Correction – Removing the clamp (Shown with the arrows in Figures #1 & #2) will allow the shaft to move unrestricted and without any "catching"
