## **Microbird MBII Entrance Door**

Body Tech Tip #14-0929

## DOOR WHISTLE ON MICRO BIRD MBII MODEL BUSES

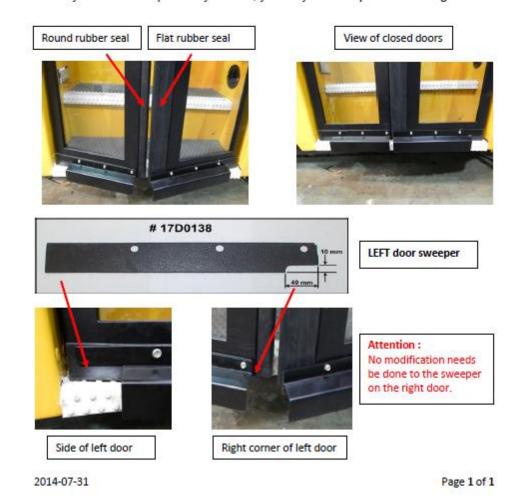
Cause – The LEFT HAND door panel "Sweep"

Customers have been reporting that on some MBII they own, the double entrance doors are whistling on the road. We have not taken this lightly and have done some changes to our design to avoid this.

- We started by inverting the door seals.
- We installed rubber sweeper behind the door stoppers which, at first, was full length.
- The design of that part has been revised and now has a new shape. If you have sweepers on your bus, you may cut it as per the drawing below.
