### **Product Affected – Chev/GM Chassis and V-8 gas engine**

# **#PIP4775: SES Light Due To P2181 DTC - Inspect Rear Heater Operation And Hose Installation - (Mar 12, 2010)**

Models: 2010 Chevrolet Express Cutaway

2010 GMC Savana Cutaway

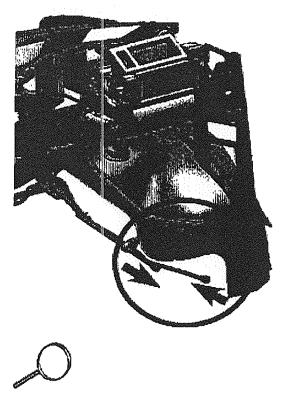
This may be the result of having the rear heater hose connections reversed or from having the rear heater fan set to high during engine warm up.

If this concern is encountered, inspect the rear heater pipes shown below for proper installation.

The longer, outboard pipe shown in blue is the coolant return from the rear heater. The shorter, inboard pipe shown in red is the coolant supply to the rear heater.

If the connections are reversed, install them correctly and re-evaluate the concern.

If the connections are correct, question the customer to determine if this occurred shortly after cold start and if the rear heat was on when this concern occurred. If so, ask them to let the vehicle warm up before turning the rear heat on and re-evaluate the concern.
