Tech Tip

From your friends at New York Bus Sales

Product Affected-All Units

Complaint - Window stops continually break from students “slamming” them open and hanging from them.

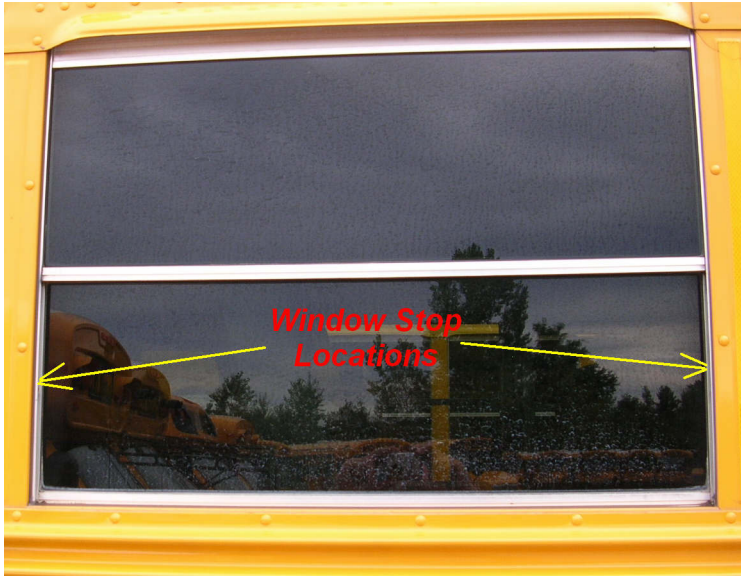
FIGURE #1

Correction - Look at the outside tracks of the windows to find the stops located 5” from the lower edge of the upper sash (Figure #1). As you can see in the close-up of the stop (Figure #2) the stop has begun to become distorted.....To the point that it will end up missing (Figure #3) which will cause the window to become cocked and worse allow it to open over the 5”NYSDOT required minimum.

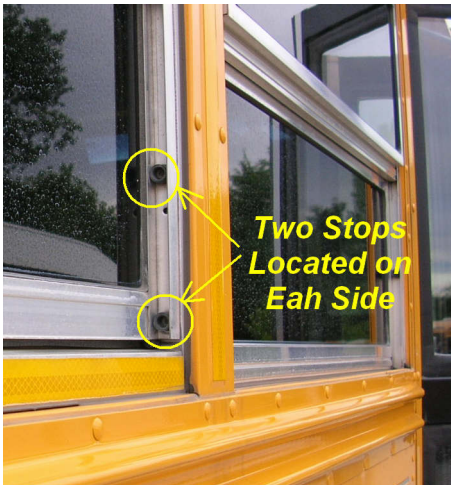
PLEASE NOTE
WE HAVE ALSO BEEN ASKED WHY SOME WINDOWS HAVE 2 STOPS IN EACH SIDE AS SHOWN IN THE PICTURE ON THE LEFT.....THIS IS AN EMERGENCY WINDOW AND THE LOWER STOPS ARE TO PREVENT THE OUTER SASH FROM SLIDING OUT WHEN THERE IS NO OPTION FOR A SPECIFIED OPENING
