Vision Gas/LPG with Code #P0504

Service Update #23-1223

Unit has CEL with code #P0504

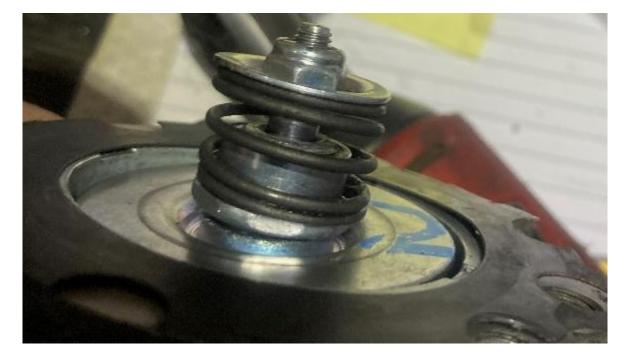
FIGURE #1

Continuing to diagnose we removed the treadle valve and without disassembling found that the rubber "spring" and Spring "seat" were visibly worn (FIGURES #1 & #2).

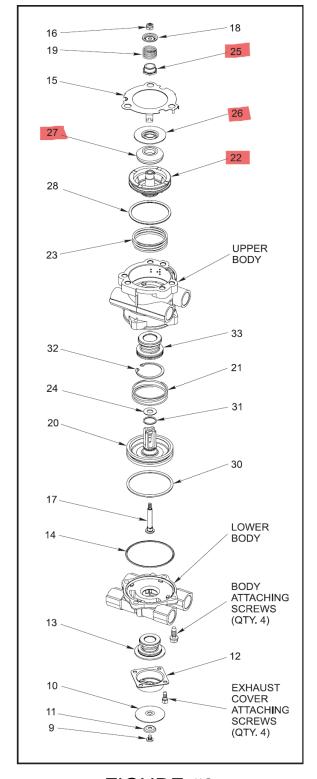
FIGURE #3 shows the complete breakdown of the treadle valve and FIGURE #4 shows the upper portion as in FIGURE #1 & #2

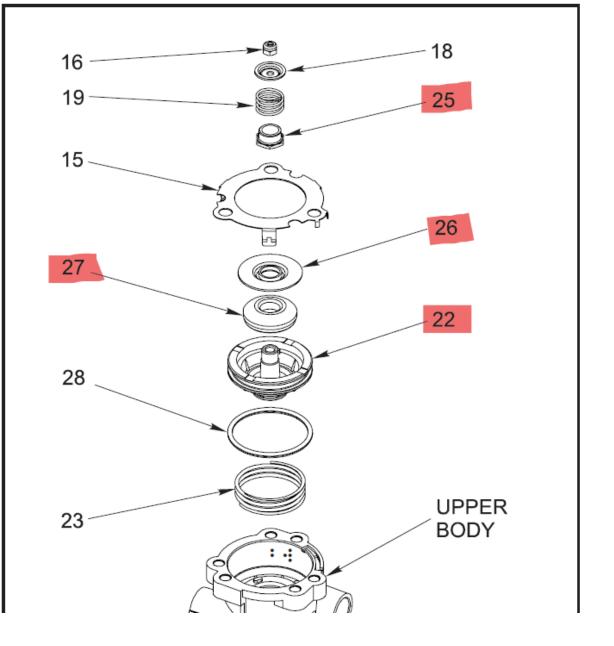
FIGURE #4

Once the locknut (#16) was removed from the threaded end of the stem and spring seat nut (#25), spring seat (#26), rubber spring (#27) and primary piston (#27) were removed, it was evident the rubber spring had worn unevenly on the shaft of the primary piston and telltale evidence is found with debris from the worn spring seat and rubber spring are shown in the "cup" of the primary piston.
