Intermittent Horn Operation

Service Update #25-0501

Intermittent Horn Operation/Grinding in Steering Column When Turning

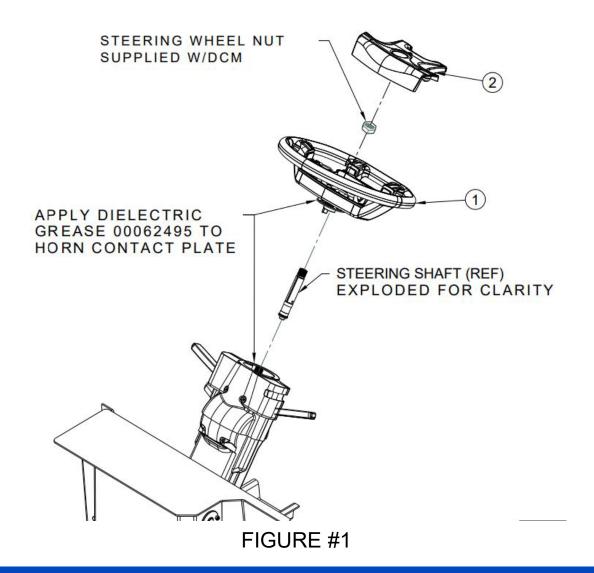
We have found that when the steering wheel is removed (FIGURE #1) the horn ring/contact is either dry or not properly lubricated. Replacing the horn ring and contact (FIGURES #2 & #3) addresses the issue when the entire tube of grease in FIGURE #2 is used to coat the horn ring.

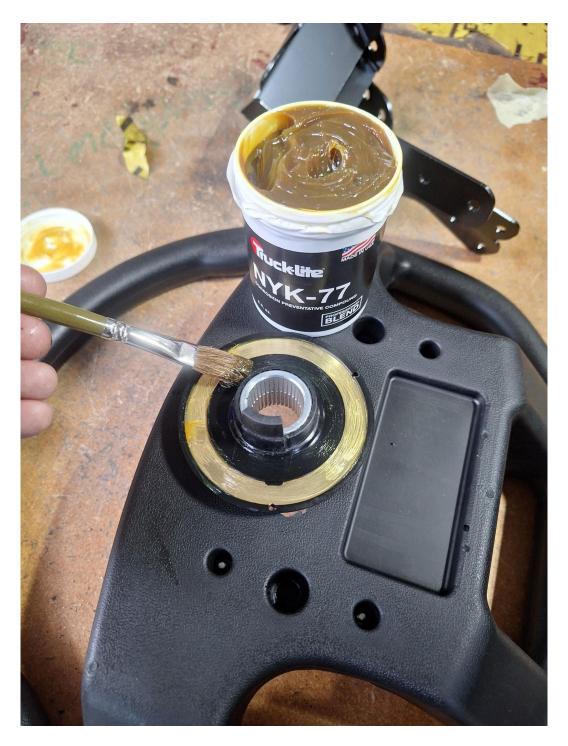
Currently as part of our <u>Pre-Delivery-Inspection</u> we are checking to make sure the horn ring is properly coated. FIGURE #4

In doing so we found that checking to ensure the ring was properly lubricated could be done without removing the steering wheel and just removing the plastic covers over the upper steering column and the dielectric grease could be applied as well.
