# Higher Voltage During High Humidity or Wet Conditions

## Service Update #25-0514

### High Voltage Errors When Humid/Wet on L-N Model “HAB”

#### Blue Bird 280 AMP – Part #10044860

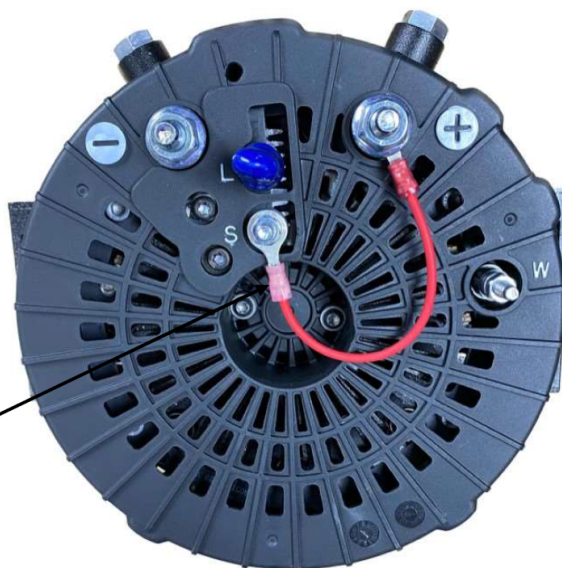
A049104702S jumper wire

If you are experiencing the alternator operating at a voltage higher than 14.5V while not using the remote sense terminal (S). Very high humidity or wet conditions could cause this to happen.

By connecting a jumper wire between the alternator's B+ and Sense (S) terminals will correct this condition.

Jumper part number: A049104702S

+ Terminal Torque: 53 +/- 11 in - lbs.  
6 +/- 1.2 Nm

S Terminal Torque: 18-22 in - lbs.  
2.0-2.5 Nm

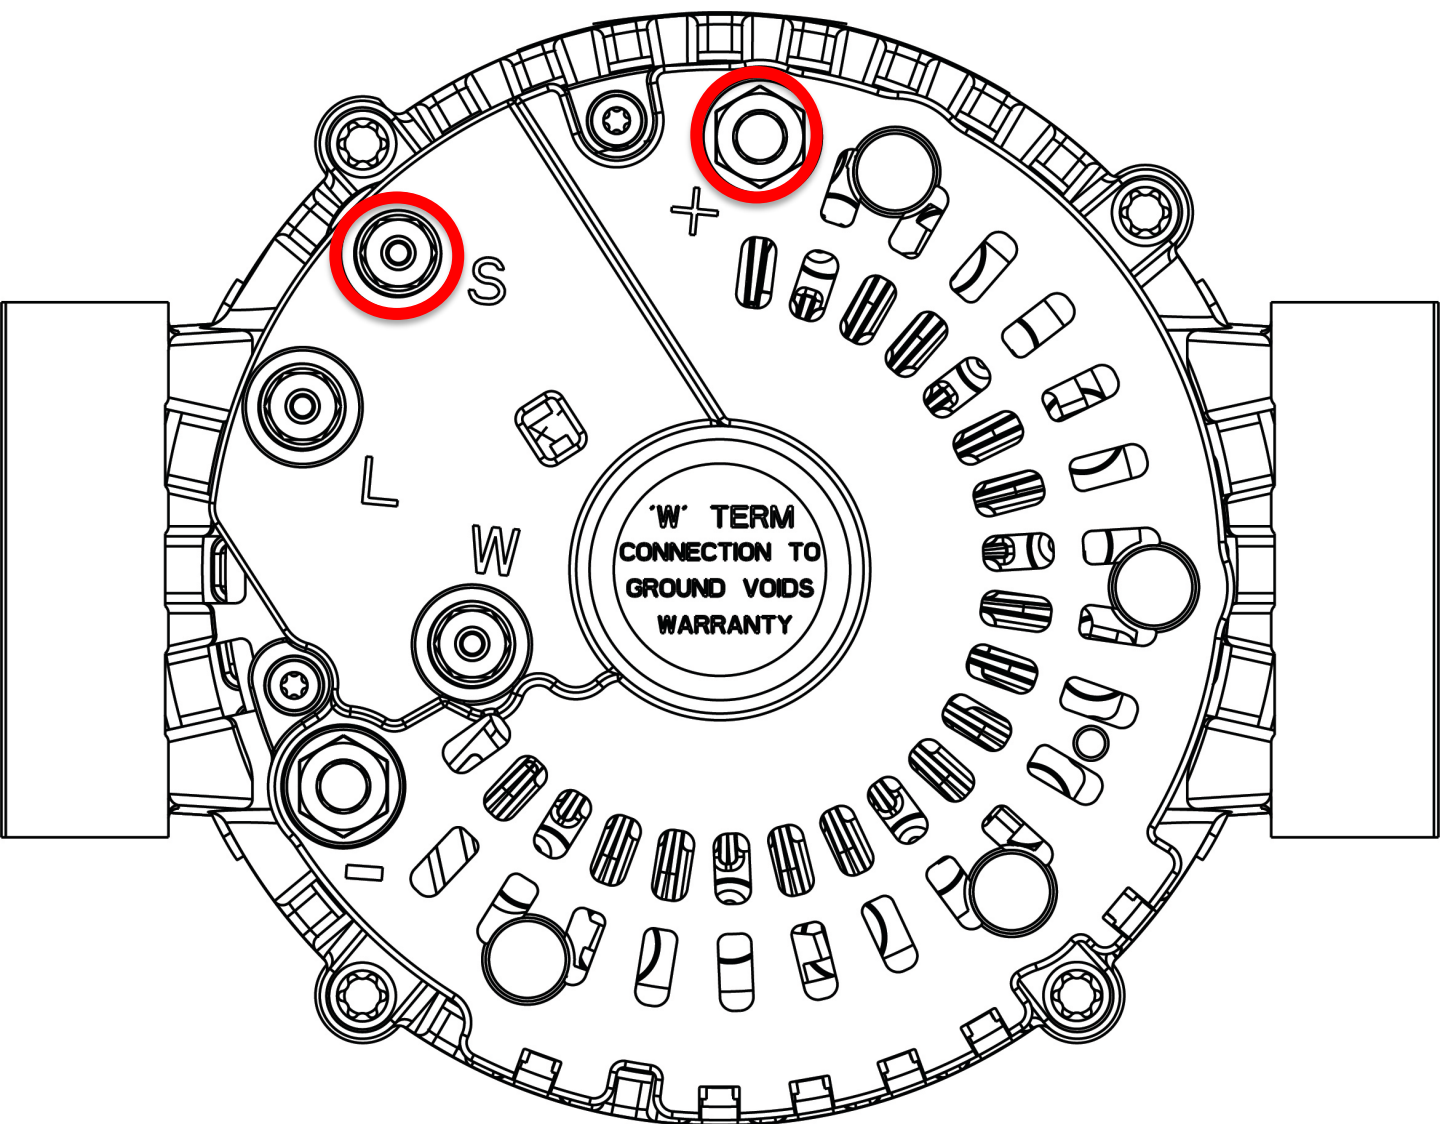
Positioning of the B+ and S terminals are not necessarily in the same position from the various AMP ratings of the model AVI160. The 240 AMP unit has a slightly different position as shown in FIGURE #2 above, both terminals are circled in **RED**.

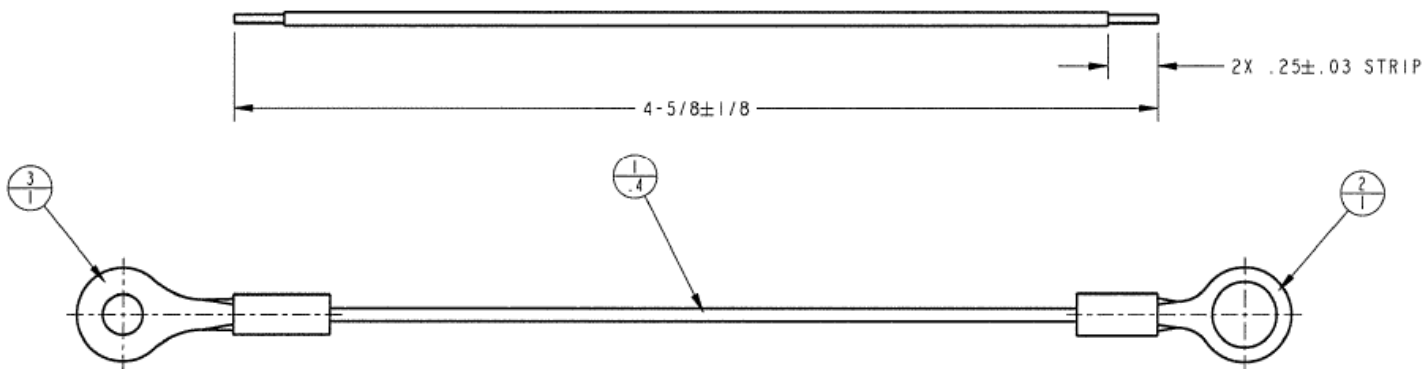
FIGURE #1

We have found that the jumper part number is not readily available, but we were able to get the specs on the jumper and found that most shops carry the common supplies to make the jumper. (FIGURE #1)

The jumper can be made using the supplies listed below by taking the wire, stripping  $\frac{1}{4}$ " of insulation off of each end and then crimping the terminals on each end.

- 1 4-5/8" 18ga. RED WIRE
- 1 5/16" RED RING TERMINAL
- 1 #12 RED RING TERMINAL
