FORD TRANSIT VAN CROSSMEMBER ISSUES

Service Update #22-0505

CHECK TO ENSURE CROSSMEMBERS ARE SOLID

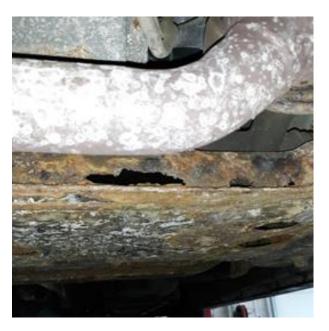
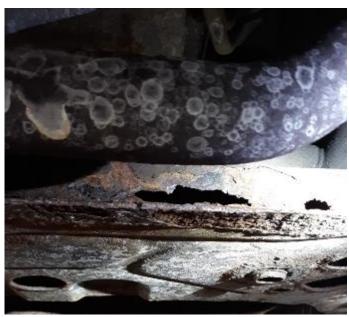
FIGURE #1 FIGURE #2

In our Service Fleet, we operate several Ford T250 Transit vans and previously during a service we found that the Suspension Subframe Crossmember had rusted (FIGURES #1 & #2), and first thought is "how are we going to fix this?"

After researching we learned that this is a replaceable piece and available through Ford. We proceeded to replace as the rest of the vehicle is in good shape.....and to help ensure no future issues we sprayed cavity wax and undercoating inside as it appeared to have corroded from the inside out.

We recommend close attention be paid to the crossmembers of these chassis when servicing and surface rust be removed with a scraper to ensure there is adequate metal and no holes forming.

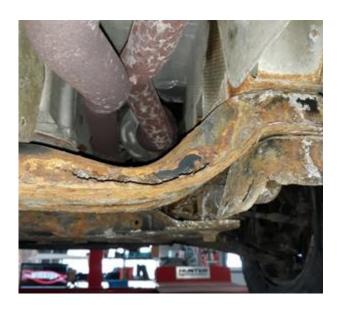
FIGURE #3

We recently have had other units we were servicing and have found the same issue along with issues where the crossmember located at the rear of the transmission (FIGURE #3) had corroded to the point of having a hole.

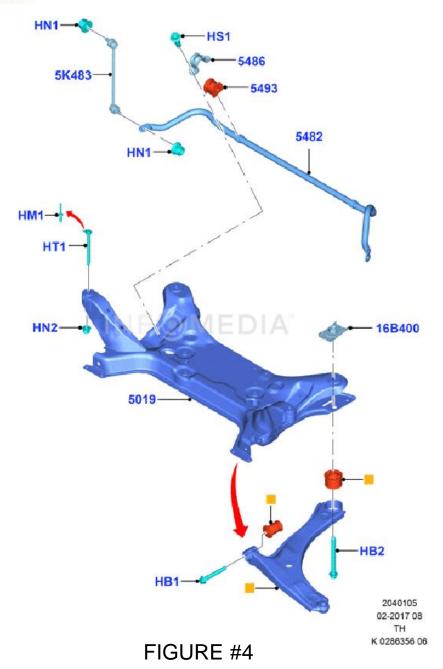
FIGURE #4 shows the exploded diagram of the Suspension Subframe Crossmember and attachment

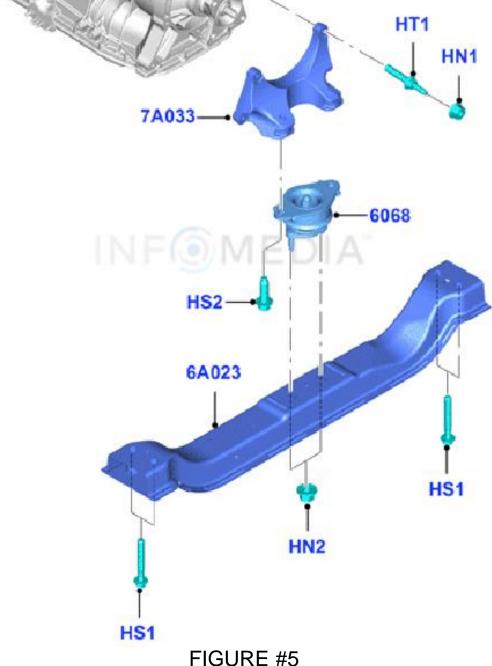
FIGURE #5 shows the exploded diagram of the rear transmission crossmember and attachment.
