## TECH TIP

### Side Marker Light Glare When Backing

### SIDE DIRECTIONAL/MARKER LIGHTS

### NEW BUS OPTION #LGT-132

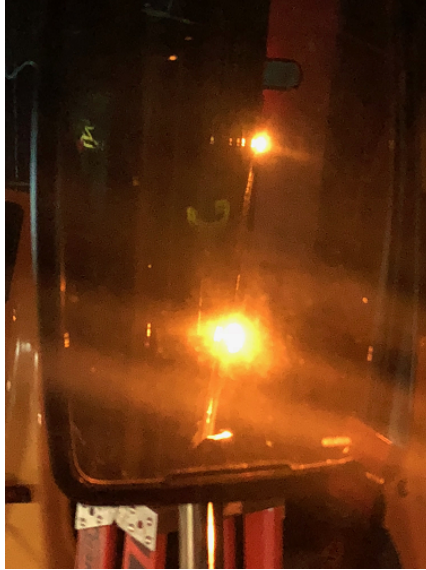
These lights are designed with basically 2 lights in the housing and the rear light is the directional where the front light is the marker light. Being LED, it is very bright and as you can see in Figure #1 when dark and trying to back the glare in the mirror can make it difficult to see.

We have verified that these lights are “ONLY” required to flash as turns. Seeing as these lights are “pre-wired” we have gotten with SoundOff and verified that if the proper procedure is followed to ensure no water wicking through cut wires the warranty will not be affected.
