Tech Tip

Product Effectuated – Units w/Specialty Stop Arms

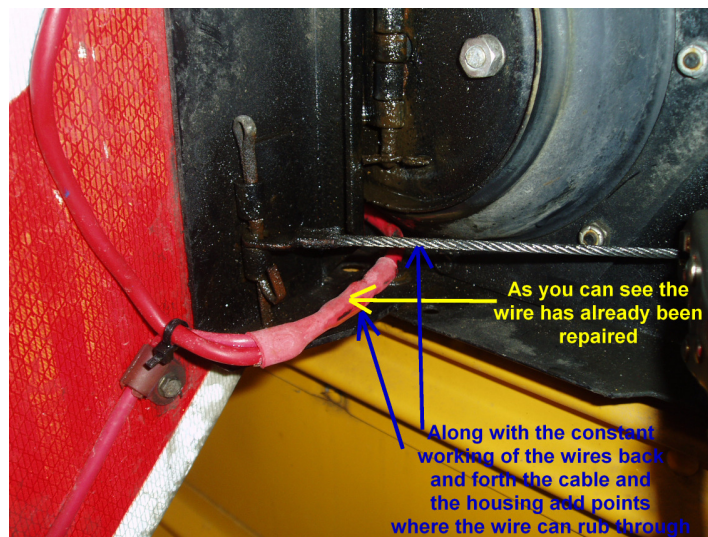
Figure #1

- Complaint -** The wires to the lights on our stop arms are constantly breaking.
- Cause -** The routing of the wire is in such a position that with the constant movement of the sign back and forth that the wire weakens and breaks. (Please see FIG #1)
- Correction -** When you remove the stop arm base cover you will notice a hole in the bottom just in front of the pivot (Please see FIG #2) and if you find a grommet to fit that hole or a piece of rubber hose you can run the wire down through to the lights allowing a loop to form (Please see FIG #3) and this will allow the stop arm to work without bending and weakening the wire.
