# **Warning Light Switch & Wiring**

New Update #19- 0622/Revision of Tech Tip #14-0610

### **UPDATED WARNING LIGHT MASTER WIRING**

# Warning Light Switch & Wiring

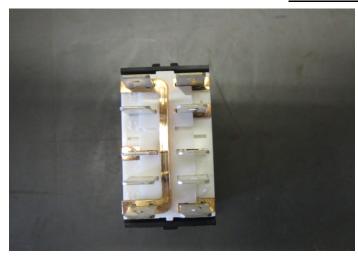
Figure #1

- #1- On the back of the switch you will notice 2 brass terminal "jumpers" as seen in Figure #1. Remove them from the switch (Figure #2).
- #2- Place the longer jumper between terminals #7 and #8 as shown in Figure #3.
- #3- For the Vision (BBCV) product, use the schematics in Figure #4 to connect the switch and for the T3FE/RE (All American) product, use the schematics in Figure #5 to connect the switch.

The new switch being used is part #00123239 which allows us to eliminate the 2 relays which were previously required but to use the switch it is still necessary to modify the jumpers on the back of the switch and should be done as follows:

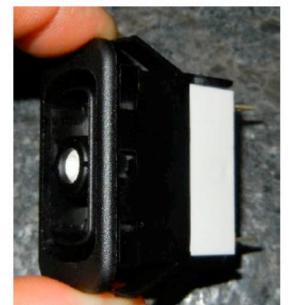
FIGURE #1

Due to popular demand from customers, New York Bus Sales has been changing the Warning Light switch set up on units to simplify operation for drivers. Previously there were 2 switches, a "MASTER" which armed the system and a "START" which would activate the lights (FIGURE #1). With the change there is now only one "3 position" switch which is marked "MASTER" that is "OFF" when down and is "ON" when in the middle position, it "ACTIVATES" the warning lights when pressed up (momentary operation) (FIGURE #2). In doing so we have changed some of the wiring and also slightly modified the switch and if the switch is changed without making the modification all the body lights will illuminate when the switch is activated.

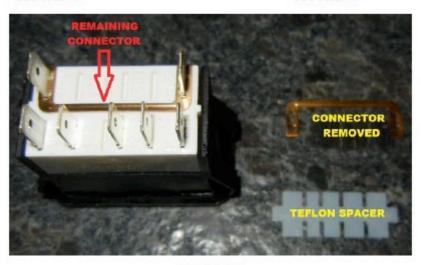
FIGURE #7

Switch part # is 00027288 (FIGURE #3) and if you look closely at the spades on the back of the switch you will see a brass "connector" which is used on the switch for ground transfer from 2 spades (FIGURE #4). As you can see from the attached schematics for both the BBCV and T3 product, those spades must be separated and to do so the connector must be removed. Using a small flat headed screw driver or a knife, pry up on the connector (FIGURE #5) and it will slide up the spades and away from the switch (FIGURE #6). Once you move the connector away from the switch base you will notice a thin piece of Teflon which is just below the connector which separates the connector being removed from another connector which is required to remain on the switch and is shown on the schematics (FIGURE #7). Once removed the Teflon spacer and

connector can be discarded and the switch plugged in. Test to assure the issue has been resolved.

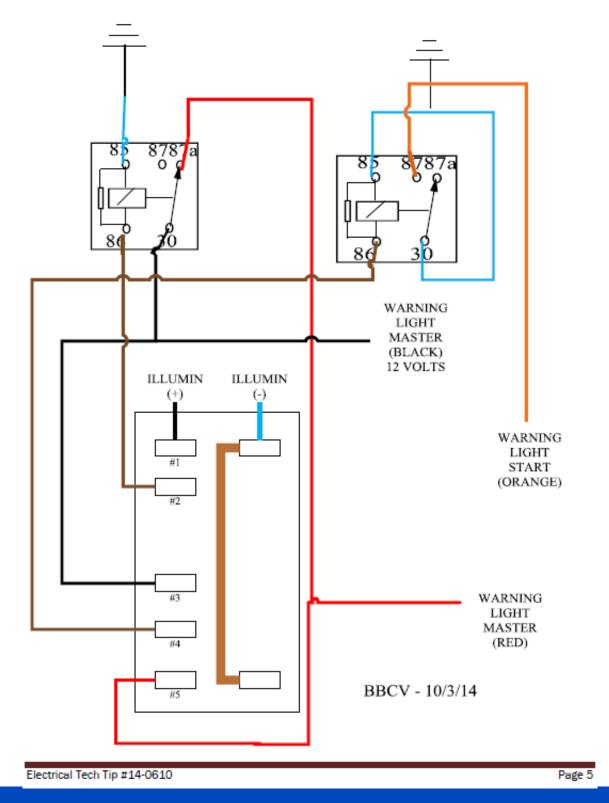
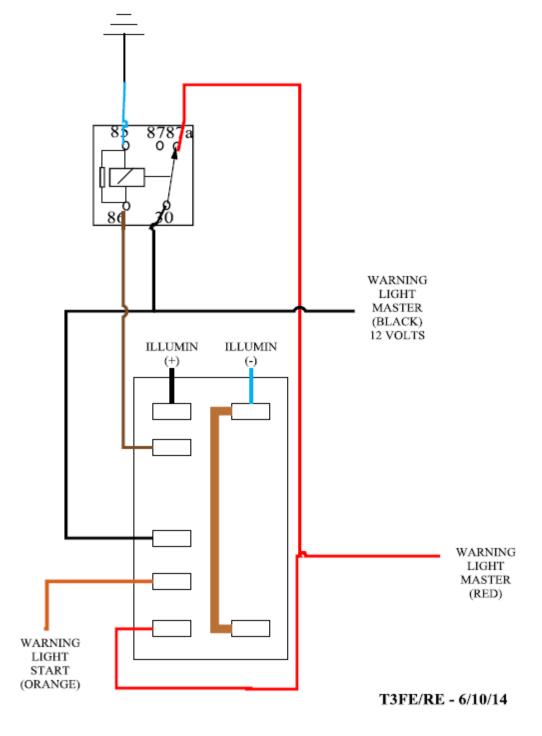
Should this fail to address the issue, attached are copies of the schematic should you need to diagnose an operational issue further on either the BBCV (VISION) or T3FE/RE (All AMERICAN). Relays will be found in the electrical panel under the driver's window.

- Check the switch operation prior to installing as we have seen some "mechanical" issues....those that when the rocker is installed on the switch it seems to "bind" and not work smoothly
- Check continuity, using an ohm meter on spade numbers 2 and 3 of the updated BBCV diagram below, you should have continuity in the "OFF" (Down) position and not in the "CENTER" (On) position or the "MOMENTARY" (Up) position.
- Check continuity, using an ohm meter on spade numbers 3 and 4 of the updated BBCV diagram below, you should have continuity in the "MOMENTARY" (Up) position and not in the "CENTER" (On) position or the "OFF" (Down) position.
