## Microbird T-Series Driveline Guards SERVICE NOTICE #18-0105REVC

### Proper Driveline Protection Required

New York State Department of Transportation has determined that the Microbird T-Series units (Ford Transit Chassis) have an issue where the brake lines are not properly protected should the driveline fail.

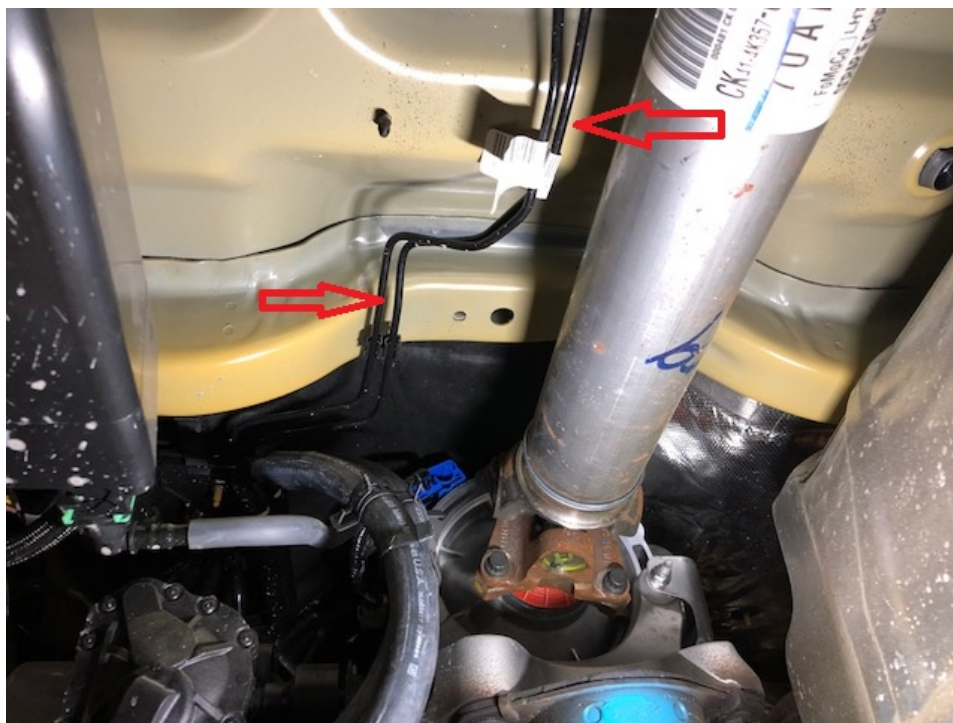
FIGURE #1

At the forward end of the driveline just aft of the transmission, the brake lines can be seen running above the driveline (FIGURE #1).

**Drive Shaft Guard:** The longitudinal drive shaft on buses with a capacity of 10 passengers or more shall be protected by a metal guard or guards to prevent the front end from dropping to the ground, as well as preventing any damage to the brake and fuel lines and exhaust system or from whipping through the floor in the event of a fracture or disconnection.

Place a straight line device that is as long as the driveshaft parallel and against the top of the tube. Hold one end of the device against the driveshaft and rotate the opposite end outward from the tube until the straight line device contacts the guard.

Repeat for the opposite end. If the straight line device comes into contact with any of the components listed in 720.4 (Y) (1) (i) requiring protection, prior to contacting the driveshaft guard write OOS Item 43.03.1 (C) or 43.03.2 (C) as appropriate. One or more loops that will prevent either end of the driveshaft from hitting the ground or the aforementioned components may meet the requirements of the regulation. Guards may be placed on individual components when a loop does not provide all the protection necessary.

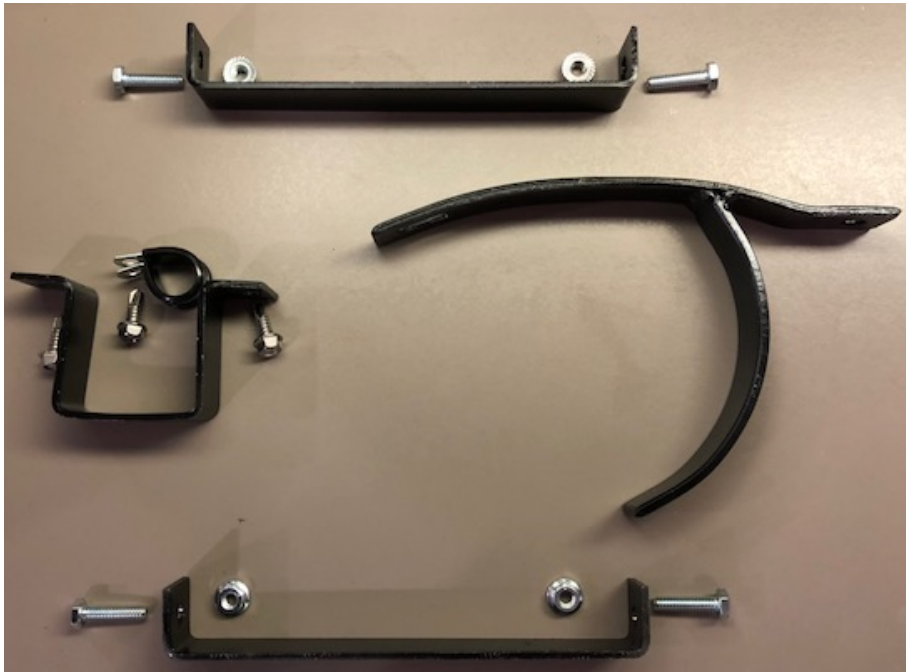
FIGURE #2

It was also determined that the guards in the rear of the units needed to have additional protection above the driveline and a “kit” has been designed to address ALL issues using 3/16” X 1” steel flat stock, #14 X 3/4” stainless steel hex head self tapping PK fasteners and 1/4” X 1” bolts with serrated flange nuts and SS wire loom fasteners. (FIGURE #2)

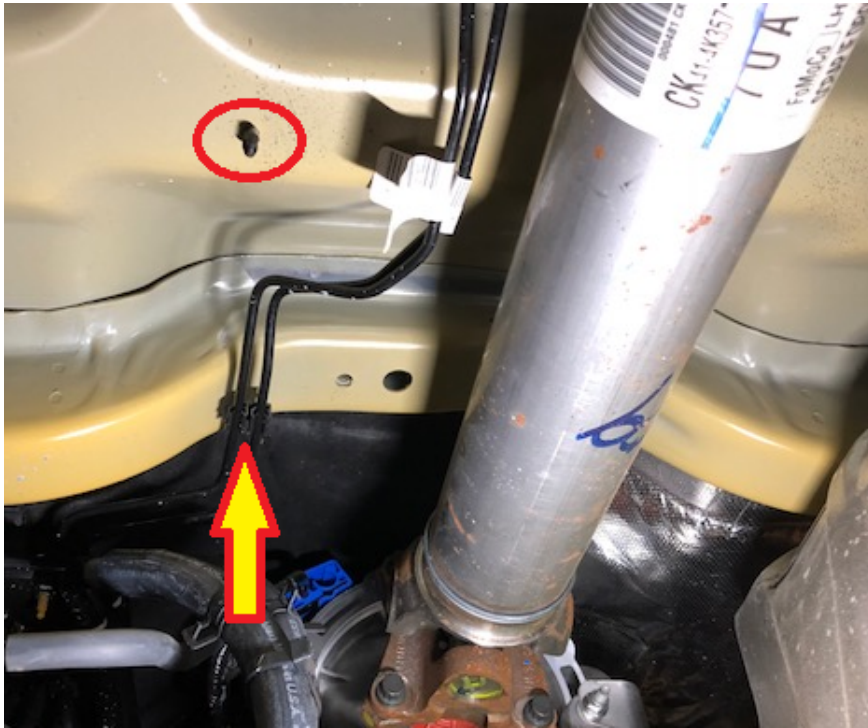
FIGURE #3

The first step is to move the plastic line “separator” forward as shown with the arrow in FIGURE #3. You should also notice that the forward cross member is “fabricated” and not formed into the floor pan as the one to the rear.

PLEASE NOTE- The formed portion of the floor should NOT be drilled into nor should any screws be put into it. The black plastic “nub” which protrudes and is circled in red (FIGURE#3) is the holder for a wire loom which runs across the cavity formed! This steel is much harder and will require pre-drilling with a 13/64” drill bit.

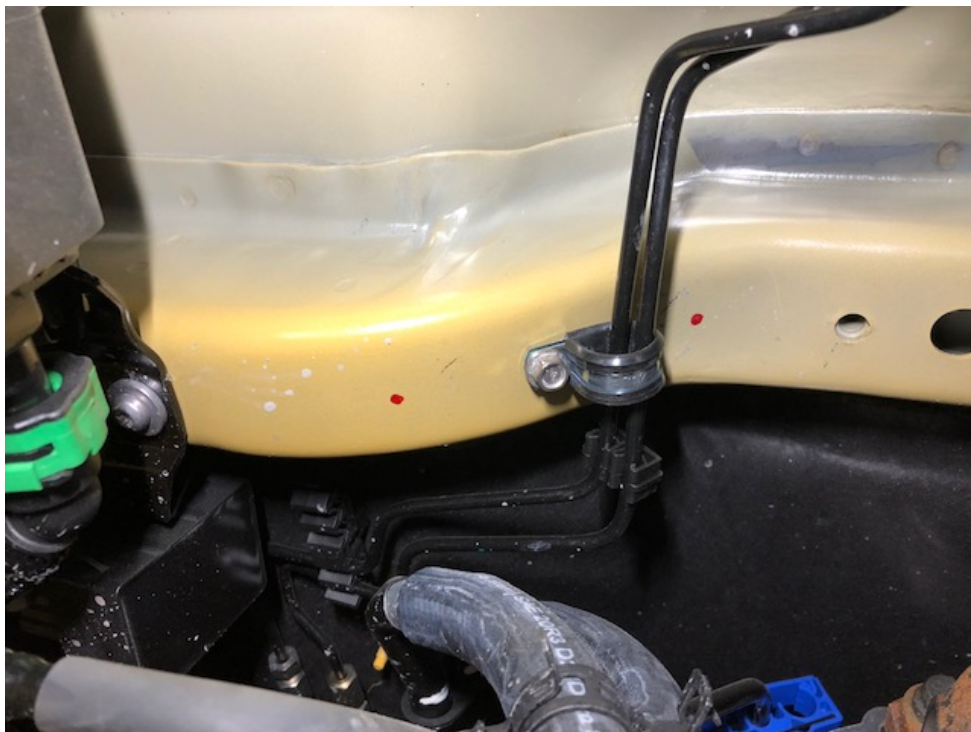
FIGURE #4

Next put the SS wire loom fasteners around the brake lines and position them on the fabricated cross member as in FIGURE #4. PLEASE NOTE- This steel is much harder and will require pre-drilling with a 13/64” drill bit. Drill and secure with PK fastener. Using the smaller square bracket, mark the forward cross member as in FIGURE #4, drill and install the bracket using 2 PK fasteners as in FIGURE #5

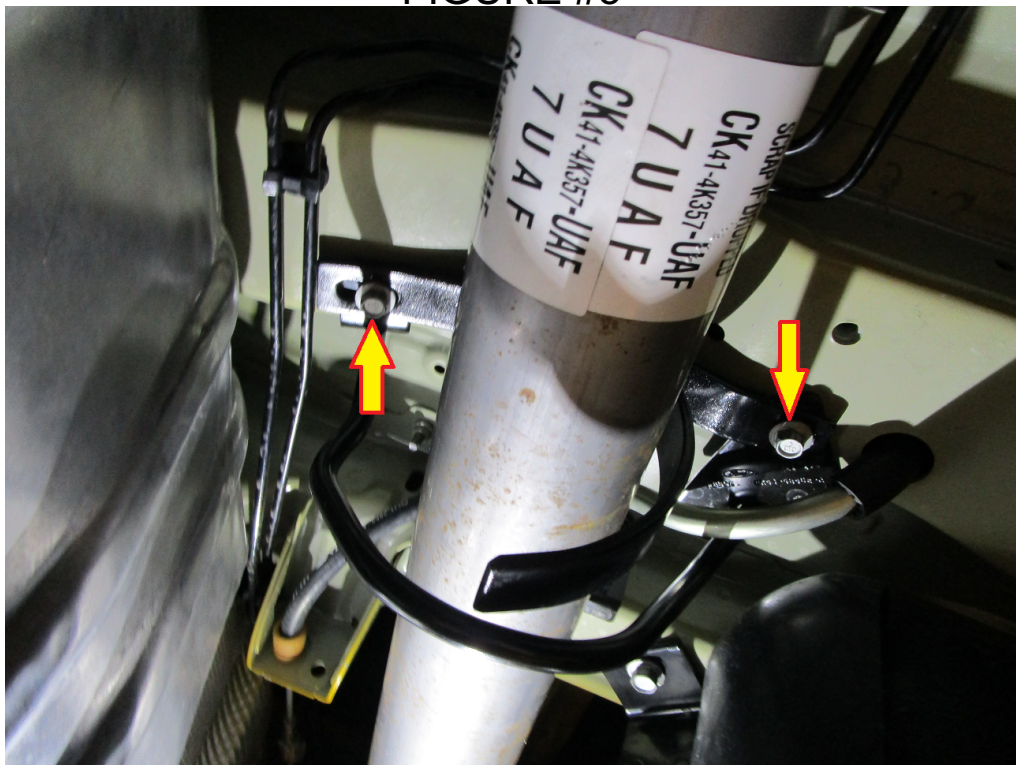
FIGURE #6

Next, the flat curved bracket with the partial “loop” will be installed above the driveline using the same holes as the OEM Ford front guard (FIGURE#6) you will notice that one of the holes in the bracket is slotted to allow for minor differences in the bolt hole spacing. Install by bolting the end with the “un-slotted” hole to the driver side which is the same side as the welded partial “loop” doing so will protect the brake lines as well as the emergency brake cable as in FIGURE #7.

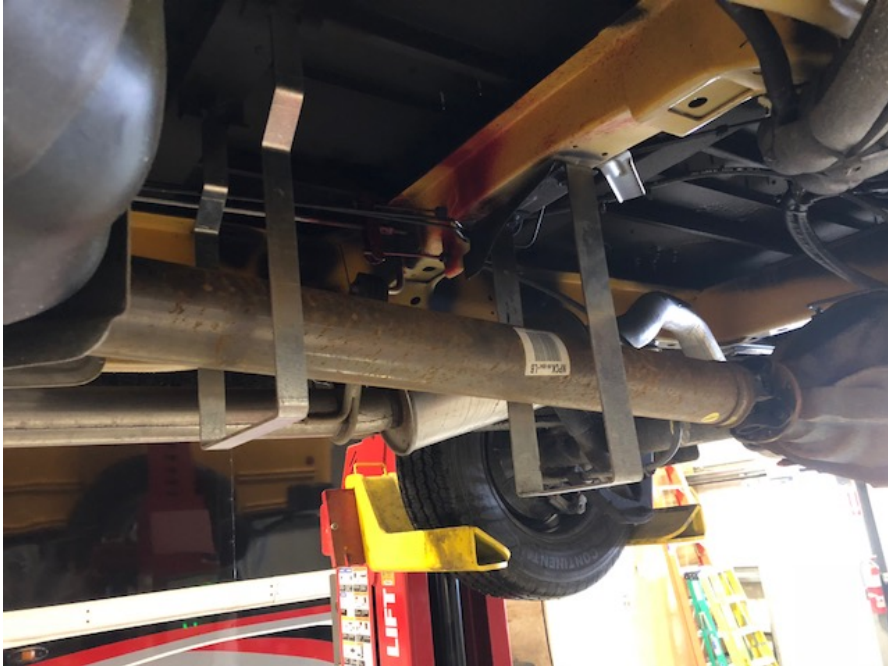
FIGURE #8

To complete, you will notice that there are 2 driveline guards toward the rear of the driveline as in FIGURE #8. Using the 2 longer brackets, position them above the driveline and inside the brackets as in FIGURE #8, the forward bracket at the highest point where it “bends” and with the rear at roughly the same distance above as the lower bend is below the driveline. Using the holes in the provided brackets drill the chassis mounted guards and secure with the 1/4” X 1” bolts and serrated flange nuts as in FIGURE#9

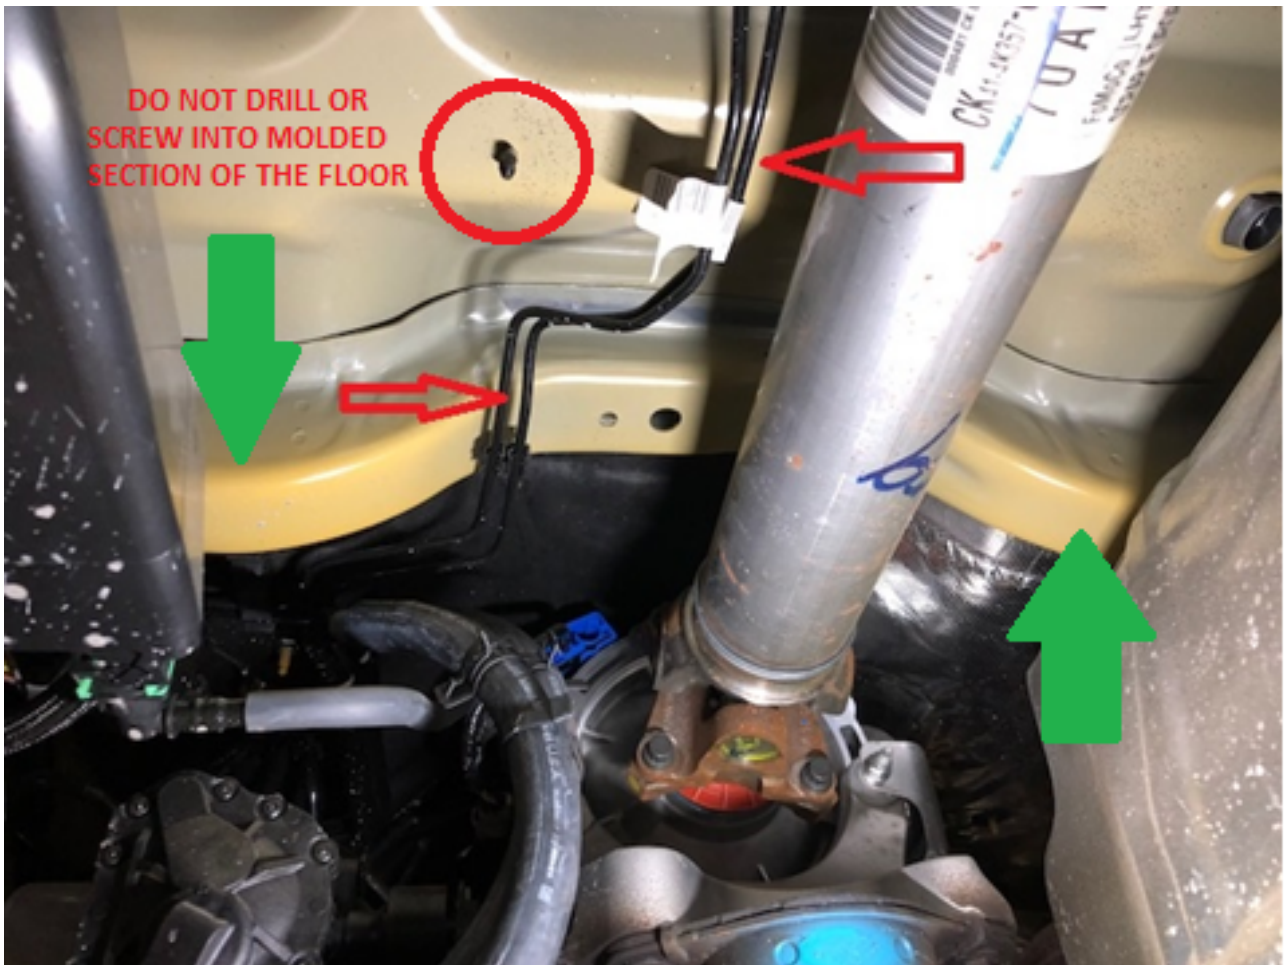
FIGURE #10

Recently we have heard of electrical issues with units which were taken to Ford dealers for repair. What was found was that when the driveline guard was installed the self-tapping screw went through a wire harness that runs across the floor in the molded recess. There is a harness clip that can be seen on the underside (Circled in **RED** on Figure #10).

Care must be taken to follow the steps and only drill or screw into the fabricated crossmember indicated with the **GREEN** arrows in Figure #10. The repair is costly as the driver seat and flooring must be removed and the harness replaced.
