# Micro Bird Water Infiltration & Water Management

## Sales Update #18-01REVA

### Micro Bird Implements Water “Management” to Address Water Infiltration

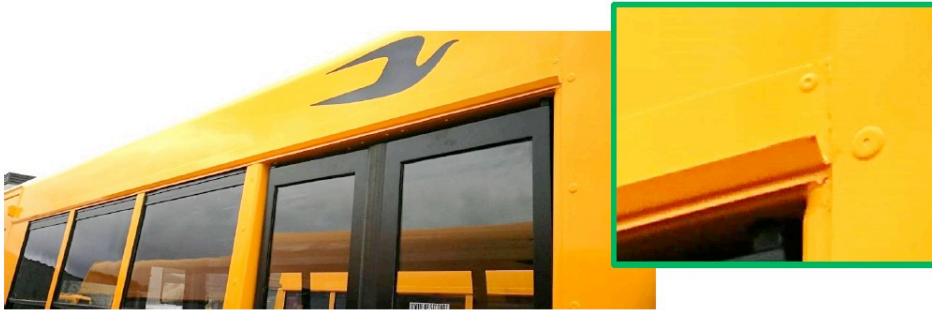
After (without drip rail / roof gutter raised by 5/16 in). The bottom of the drip rail is now unsealed, and the top of the windows are independently sealed with the roof sheet metal. This exposes the roof sheet metal edge. The top of the drip rail was and is still sealed (unchanged).

Figure 2: The esthetical aspect of the raised drip rail, now unsealed at the bottom

- Numerous vehicles have been tested with regards to water infiltration.
- The shower test has proven to replicate the water infiltration issue on former drip rail configuration, if, and only if, the “drip rail / gutter” is slightly separated from the roof.
- Once the drip rail is repositioned higher, the same shower test proved to address this type of cabin infiltration, even if the “drip rail / gutter” is slightly separated from the roof.
- Through thorough testing, no leaks were observed on the windows top, now independently sealed. Even a direct water projection (ex: garden hose), localized at the windows top, could not produce a single cabin infiltration.

In conclusion, the modification is helpful, and fully validated.

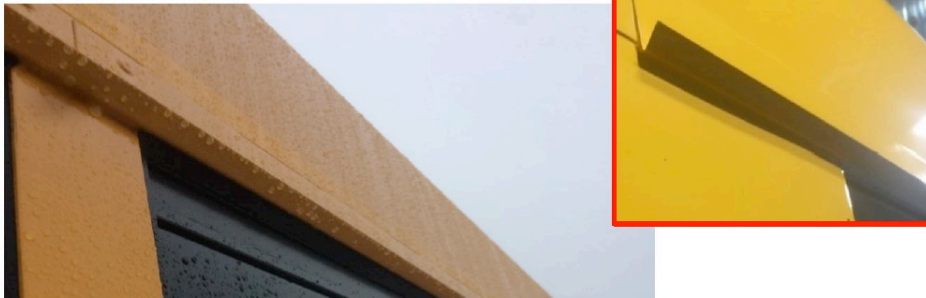
Before (Lower drip rail / roof gutter). The bottom of the drip rail used to be sealed with the windows top and with the body between the windows.

Figure 3: The esthetical aspect of the former drip rail installation, with bottom sealed with the windows top

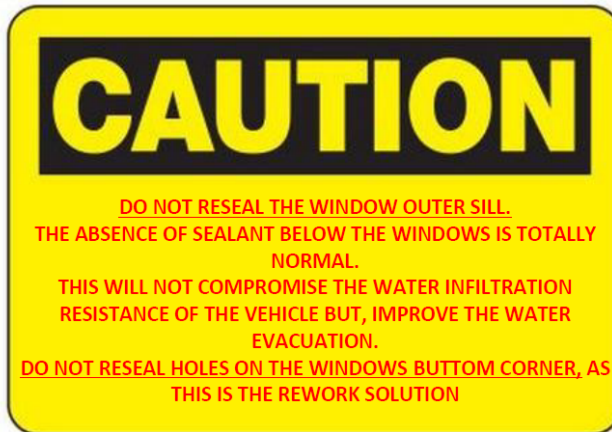
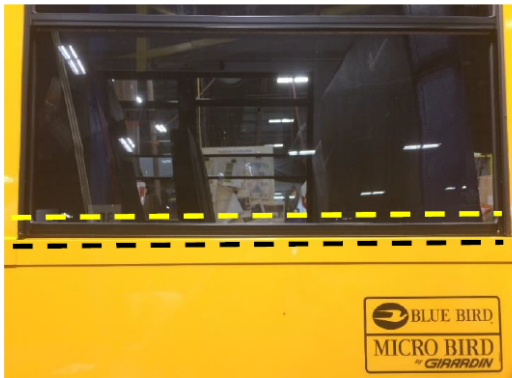
**WARNING – DO NOT RESEAL THE WINDOW OUTER SILLS**

- Numerous vehicles have been tested with regards to water infiltration.
- The shower test has proven to replicate the water infiltration issue on former window sill configuration, with sealant.
- Once the outer window sills sealant is removed, the same shower test proves to address this specific the cabin infiltration.
- Thorough the thorough testing, no leaks were observed due to the absence of sealant under the windows. Even a direct water projection (e.g.: garden hose) localized at the unsealed area could not produce a single cabin infiltration.
- Tests were also performed with “drilled sealant” (rework solution).
- While drilling, water dripping through the holes was immediately observed, supporting the added value of the drilling: it prevents most water accumulation at the window sills.

In conclusion, the modification is helpful, fully validated and should not be altered / re-sealed under no circumstance.

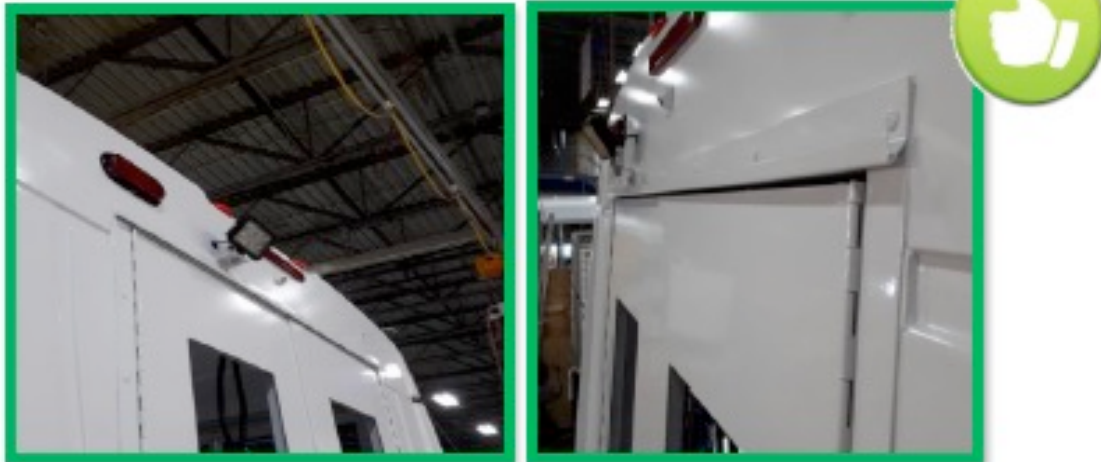
### Back-Lift Gutter

Optimized back-lift door gutter. This will apply to all models with back-lift door option (LB0-2) and for vehicles produced after December 20<sup>th</sup>, 2018.
