# Driveline Guard – Missing Brace on A3FE and BBCV Units

## Service Notice #18-1109REVA

### Missing Brace May Cause Driveline to Contact Air Brake Components on A3FE and BBCV Units

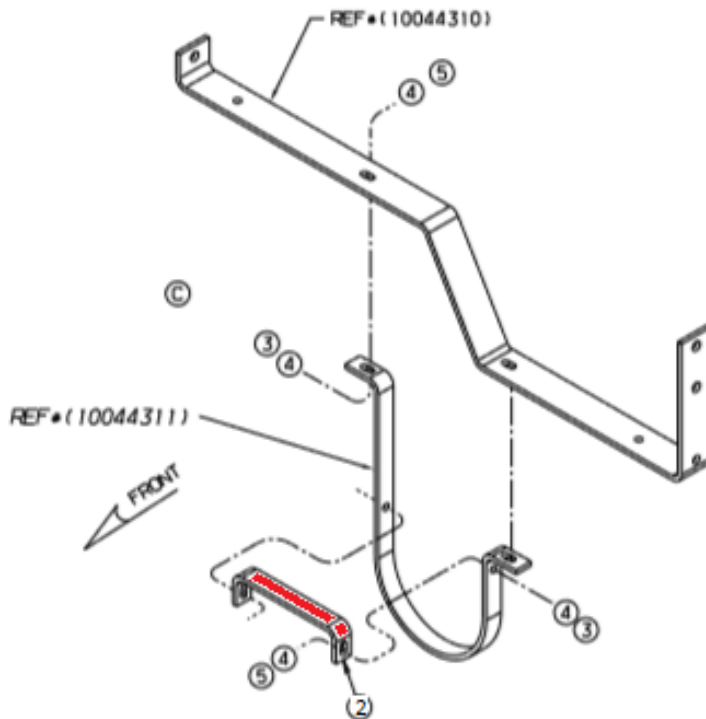
The guard in question is shown in Figure #1 and is a “mid-mount” guard which is generally mounted to protect the center section of the driveline near the air tanks as in Figures #2 & #3.

KEY	P/N	DESCRIPTION	QTY
ⓑ 1	SEE CHART	STRAP, GUARD, DRIVE LINE	1
2	10022644	BRACKET, CROSS, DRIVE LINE GUARD STRAP	1
3	00559195	CAPSCREW, HEX HD, 3/8-16 X 1, GR8, YEL ZN DICH	4
4	01107085	WASHER, FLAT, 13/32X13/16X3/32, HDN, BLKZN	8
5	00826297	NUT, HEX HD, .375-16, LOCK, YEL ZNDICH	4

TORQUE ITEM #5 29-33 FT-LBS.

Generally we have found that most units have the holes predrilled in the “loop” for the cross-brace and installing is a matter of bolting the brace (shown in red in Figure #1) and torquing the bolts to 29-33 ft/lbs.

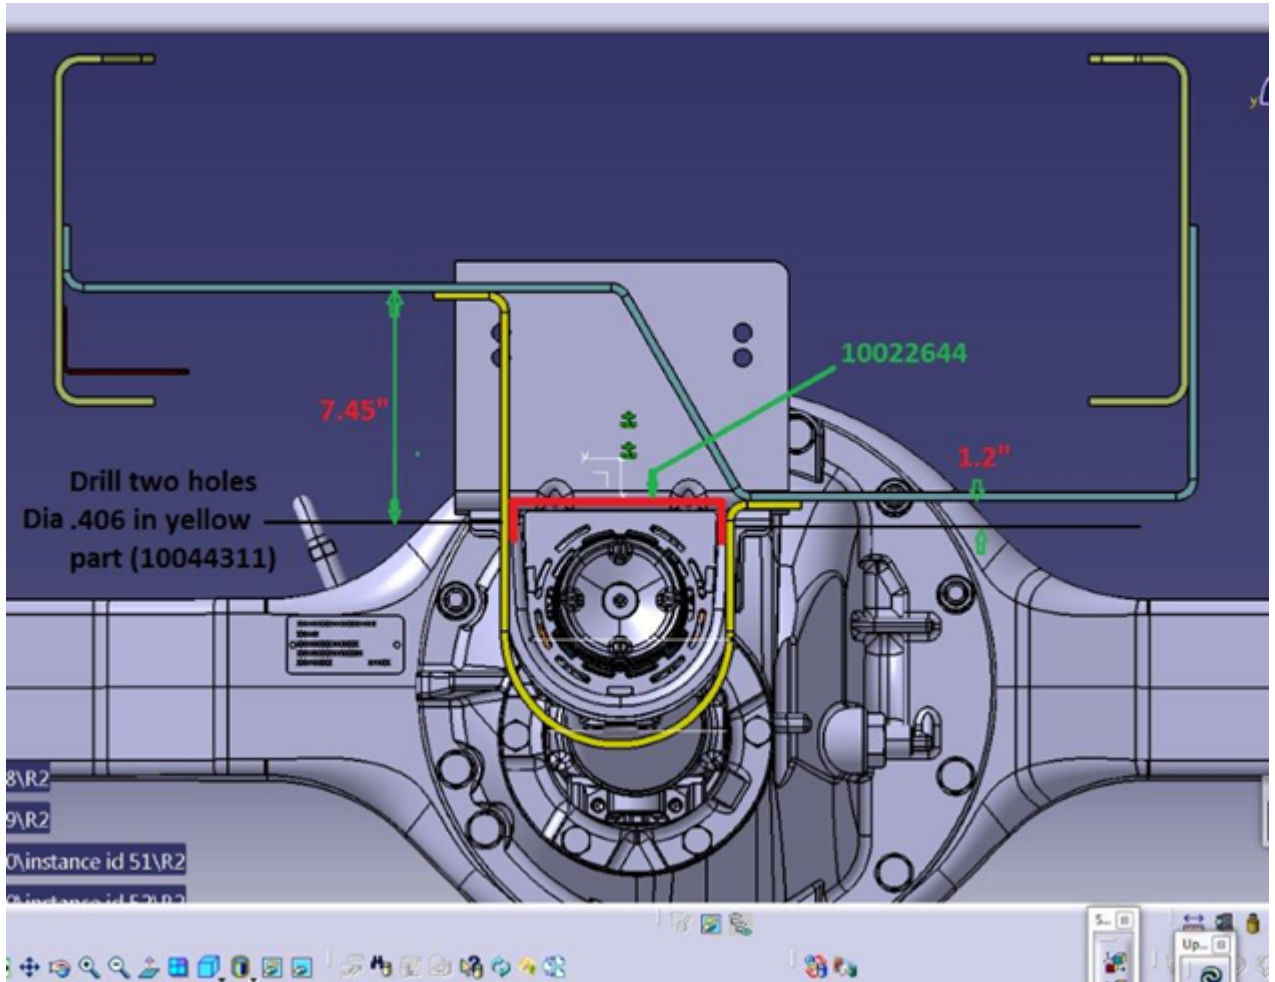
There is an added photo showing the brace placement in Figure #4 should holes need to be drilled.

## BRACE PART #10022644

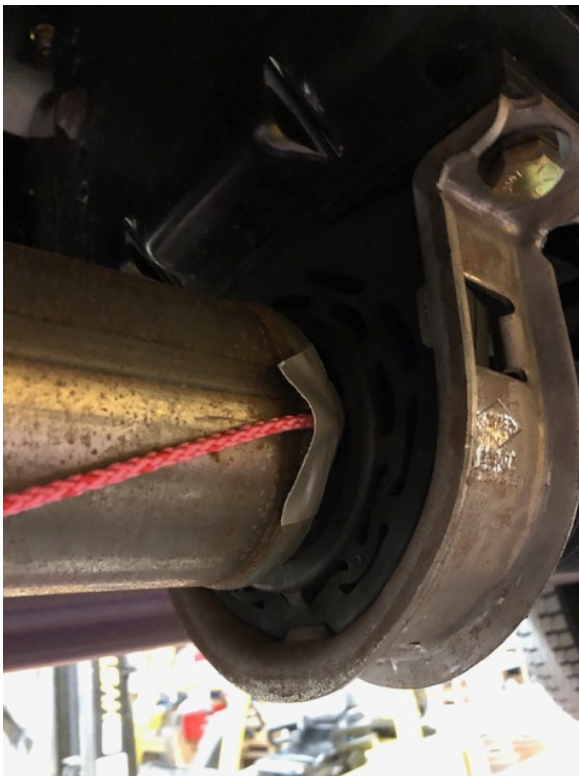
Figure #5

#1 – Obtain a string and using a tape of some sort secure the string to the driveline section in question at the rear mount. (Figure #5)

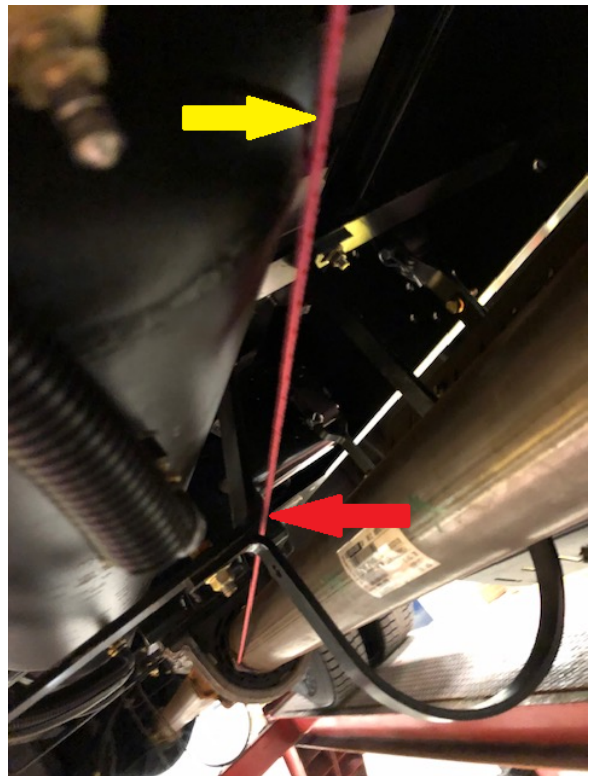
#2 – Pull the string forward through the driveline guard and straight up toward the front of the vehicle and check to see if it contacts the air tank, fittings or lines. Figure #6 shows the string touching the air tank (Yellow Arrow) while it is still a slight distance away from the guard (Red Arrow). This indicates the brace is needed.

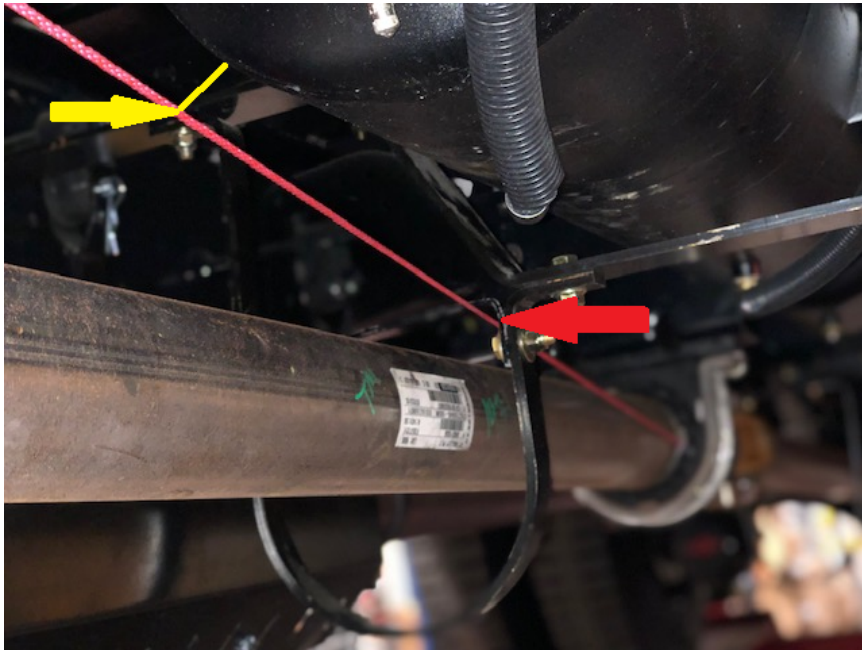
Figure #7

#3 – Once the brace is added as in Figure #7, you can see that the string is a distance away from the air tank which indicates that should the driveline fail, the guard would protect the air tank. As you can also see in the figure, the brace is fairly close to the driveline. In this instance it is at the minimal ½” spacing.

These are from a 65 passenger unit with a 252” wheelbase and as stated when used on a longer or shorter wheelbase there may be a difference in the brace

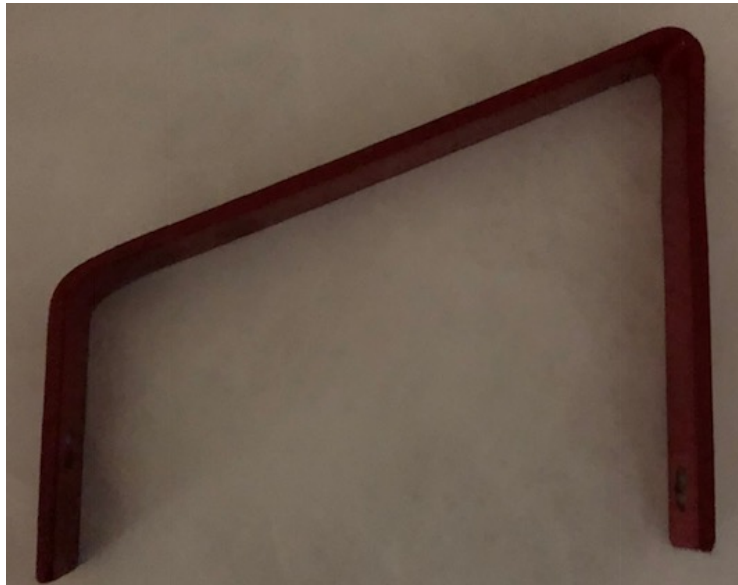
Figure #8 shows a brace that New York Bus Sales makes should the Blue Bird brace not work due to the driveline being too high in the guard. This brace is also NOT drilled so that correct placement can be made.

## **EXTENDED BRACKET PART #NYB-085**
