Micro Bird Entrance Door Adjustment SERVICE NOTICE #18-1218

TITLE: Passenger entrance door adjustment

PRODUCT: Micro Bird buses

MBSB-103-18 English rev. 1

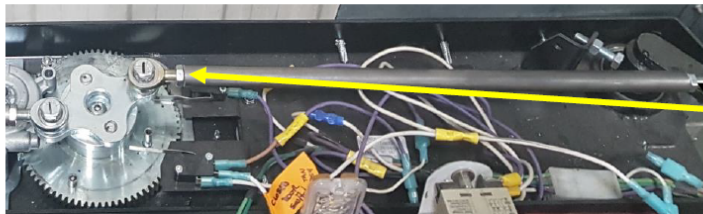
Nuts to unscrew

1. Open the emergency exit to release tension on the threaded rods.
2. Unscrew both nuts at the end of each rod.

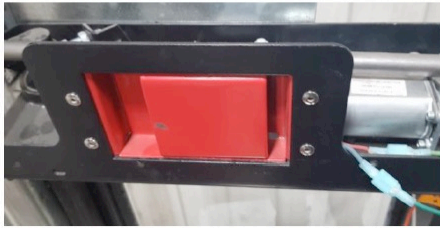
Stepwell light

6. Maintain the gear in position. Close the emergency handle. Use the console switch to close the doors. Hold the switch until the stepwell light is off. The gear will be at a precise location and the microswitch will be activated.

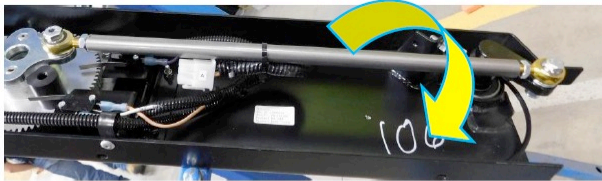
7. Adjust the entrance doors using the rods starting with the right one. Turn it towards you until the right door frame hits the steel corner on top of the door. Lightly screw both nuts to secure the rod.

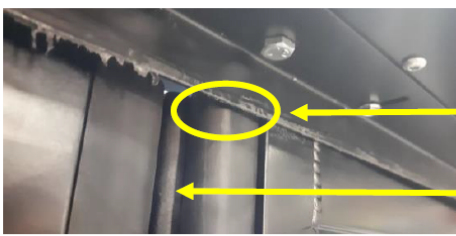
Slight contact

8. Proceed with the left rod, this time turning the rod away from you. Turn it until the top of the left door rubber seal touches the rubber seal of the right door. Lightly screw both nuts to secure the rod.

Both seals are touching and the left one starts to be deformed.

9. To make sure the doors are as tight as should be, the last thing to do is to turn the right rod $\frac{1}{4}$ turn towards you and turn the left rod $\frac{1}{2}$ turn away from you. Tightly secure nuts.
