100 Gallon Diesel Fuel Tank #10015138 Replaced by #10058732 Parts Update #18-1010

Some Modifications “MAY” be Required When the Updated Tank is Installed

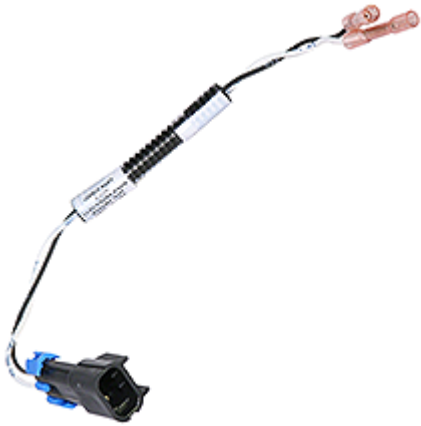
Figure #1

- The first is that if your sending unit has a weaththerpac connector, part #10052483 (Figure #1) should be purchased so that the harness does not need to be compromised.
- The second is the fact that the fuel supply port on the new tank is located in the center of the tank, which puts it about 30” to the rear of the unit from its initial location.
