2008 & NEWER BBCV/VISION HOOD REPAIR UPDATE

TECH TIP #13-0316REVC

2008/Newer BBCV – “VISION” Hood Repair

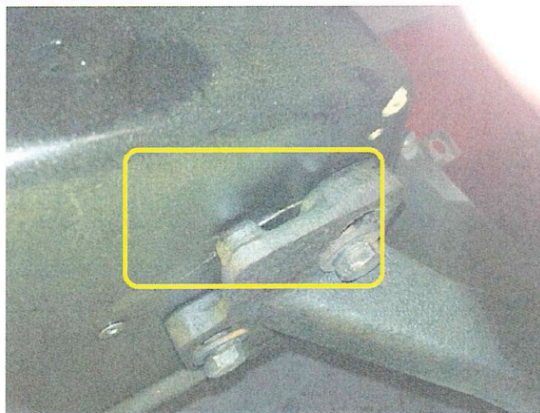
Figure #1

Complaint – The hood seems “loose” when opened/We are seeing de-lamination and “splitting” where the hood pieces are glued together.

Cause – We believe that smaller “cracks” actually start in the hinge area of the hood (Figures #1) and if not addressed over time with the opening of the hood for pre-trips etc., especially where wind can catch the hood and push it past it’s normal operating range. If this is not addressed early enough the added flex will allow other areas to de-laminate

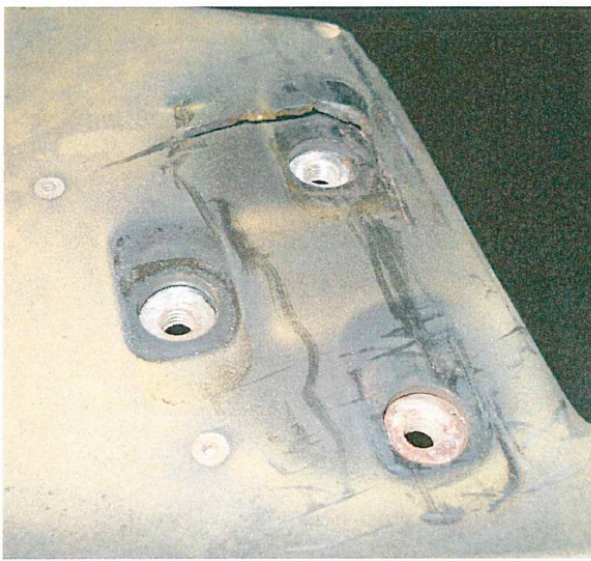
Figure #3

When you have the hinge removed you will most likely find that the “crack” is much worse than it appeared with the hinge attached (Figure #3). Our kit comes with 2 pre-bend metal plates (RH & LH) which are marked. **BEFORE PROCEEDING FURTHER, HOLD THE PLATES AT BOTH SIDES OVER THE WHERE THEY WILL BE MOUNTED AND MAK SURE THAT ALL OF THE CRACK(S) ARE COVERED....IF THEY ARE NOT FURTHER REPAIR OR HOOD REPLACEMENT MAY BE NECESSARY!**

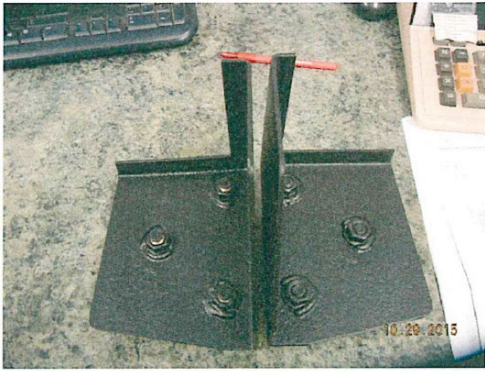
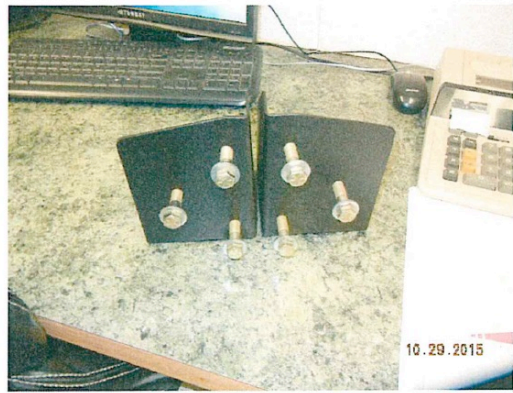
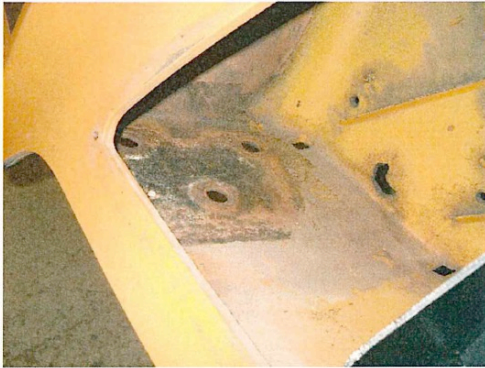
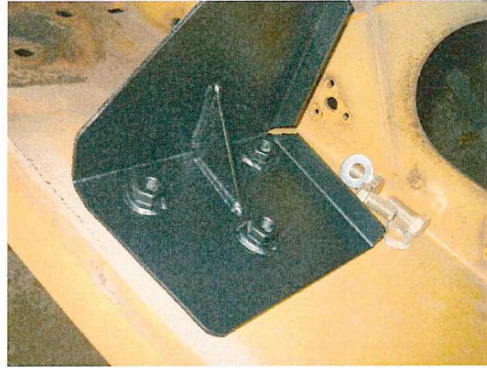
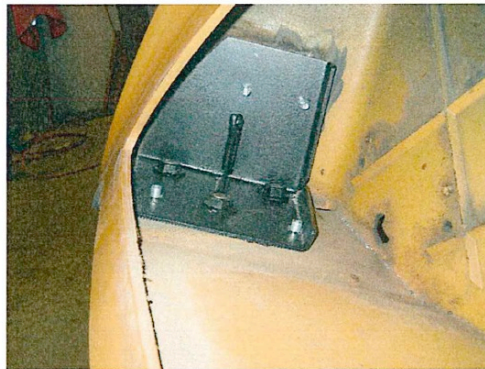
UPDATE – 12/15/15: Recently brought to our attention was the fact that some units if not addressed sooner have seen the braces inside the headlight housing opening. We now offer a replacement for those hoods that have further issues...please see below-

UPDATE – 1/4/2016: New York Bus Sales now has available a “refurbished” hood that has been checked and had all the updated repairs done and is painted and ready to bolt on your unit, we just ask that your takeoff be repairable and given back to us so we can make the necessary repairs and paint for the next customer!
