AMETEK DASH CLUSTER

Parts Update #17-0928

Dash Cluster Navigation Button Covers

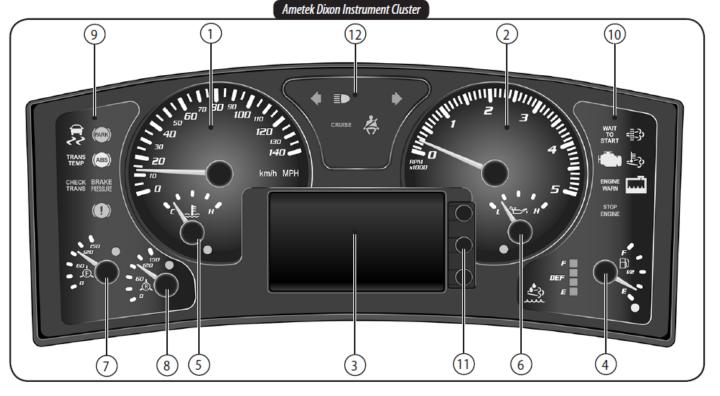
Figure #1

It's been brought to our attention that customers with the new Ametek dashes have seen the rubber covers for navigation buttons (#11 in Figure #1) come free and get lost, which require being replaced. Customers believe they may have "popped" out when the dash was being cleaned. Figure #2 shows what the dash looks like with the cover missing.

REPLACEMENT COVER
PART # LIST PRICE
10056715 \$3.01

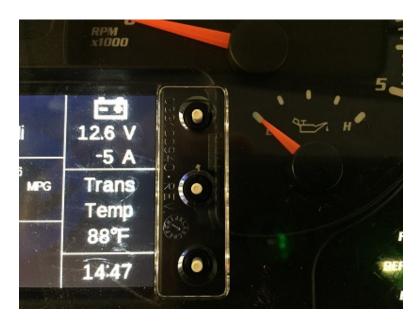
Figure #2

PLEASE NOTE – THIS IS BASICALLY A COVER TO PREVENT DUST/DIRT FROM GETTING INTO THE DASH. HAVING IT NOT THERE DOES NOT IMPEDE THE OPERATION OF THE DASH.

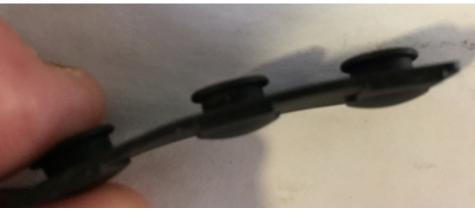
Figure #3

The actual button "humps" are not centered on the rubber strip, so attention needs to be paid when reinstalling. (Figure #3). The cover is held in place by design. The cover is designed to go over the buttons and extend through the plexiglass cover of the cluster (Figure #4).
