## Radiator Crimp

### Parts Update #15-0128REVA

### Blue Bird BBCV Radiators

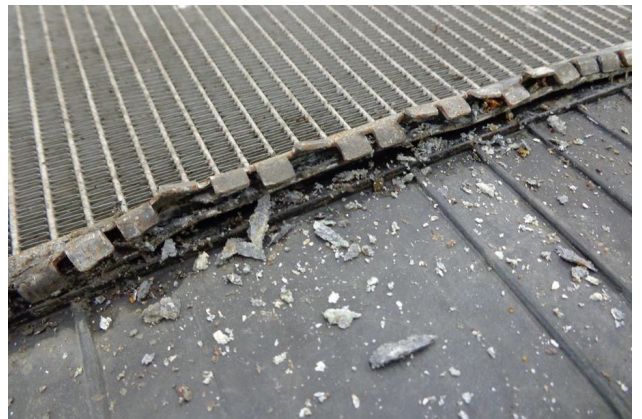
Mainly the cause has been found to be a leak where the tank is crimped to the aluminum core. Please see Photo #1 where you can see the “wet” showing on the tank. Photo #2 shows the crimp is becoming un-seated at the joint. Photo #3 shows the crimp to the point where it has actually moved away from the tank. Photo #4 shows an extreme case where the crimp has come right off of the tank.

We are in the Northeast where they use salt on the roads. This type of failure is called Crevice corrosion. What happens is a new layer of Road salt spray is being dried in place between the Aluminum Header and the Galvanized Crimp retainer. Over time as these layers build up it will actually push the retainer off the header, therefore losing the crimping of the gasket to tank joint which then causes a leak. This only happens on the bottom tank crimp joint as it hangs down between the frame rails and is the prime path for road salt.

Replace the radiator. Or in some instances radiator repair shops can remove the tank, clean and reinstall with a new crimp.
