Blue Bird Vision/Ford Transmission Tail Shaft Mount

Tech Tip #17-0706-RP-1

Transmission Tail Shaft “FRONT” Stamp

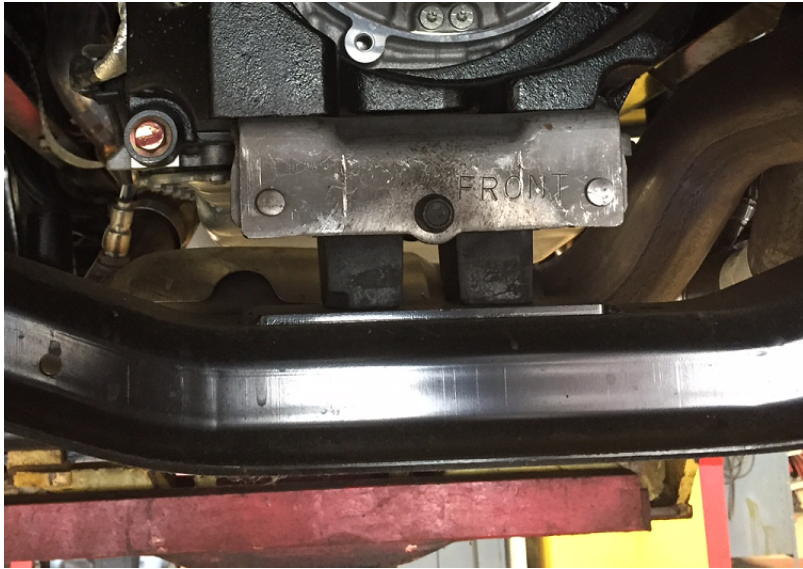
We have found that on units with the Ford 6R140 transmission, the rear tail shaft mount as pictured above, is stamped with the word “FRONT” (Figure #1).

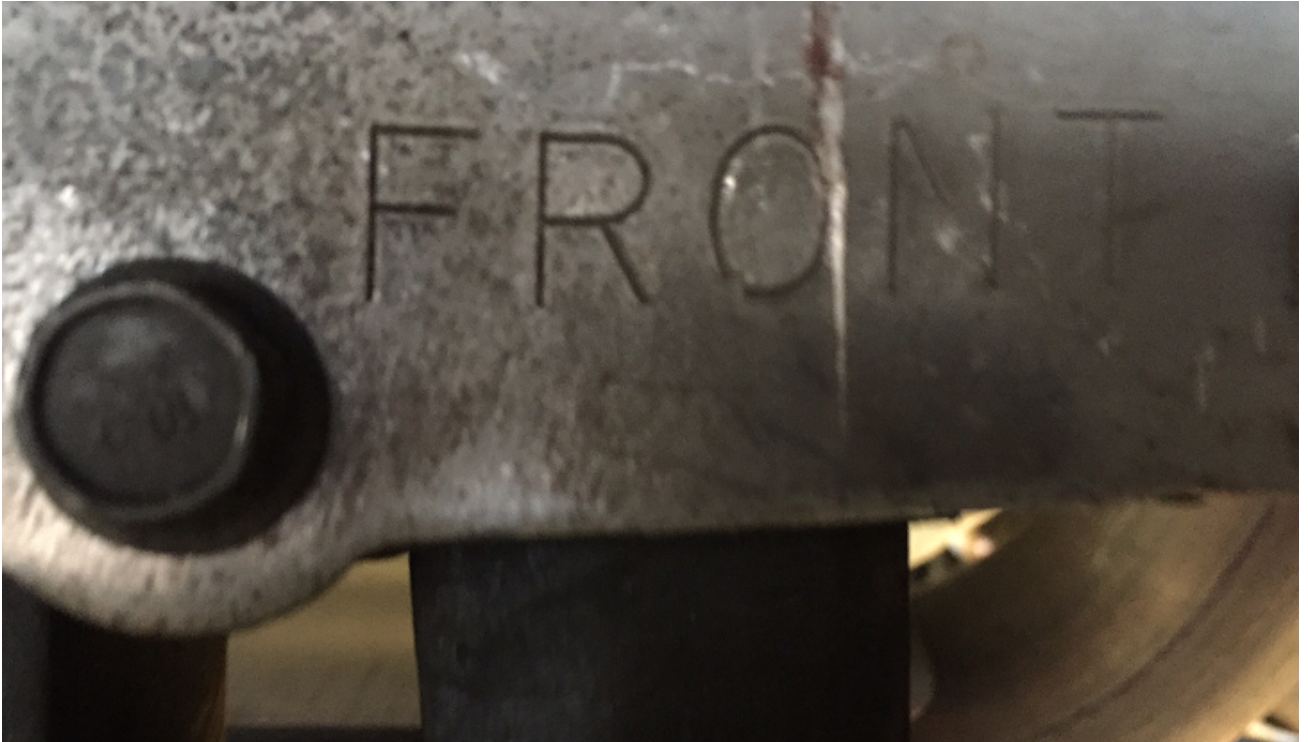
FIGURE #1

The issue with this is that the side stamped is actually facing the rear! We have contacted Blue Bird engineering and this is the correct placement of the mount.
