WATER INFILTRATION

Tech Tip #17-0527

IN TORRENTIAL RAIN A 2" HOLE CAN CAUSE ISSUES

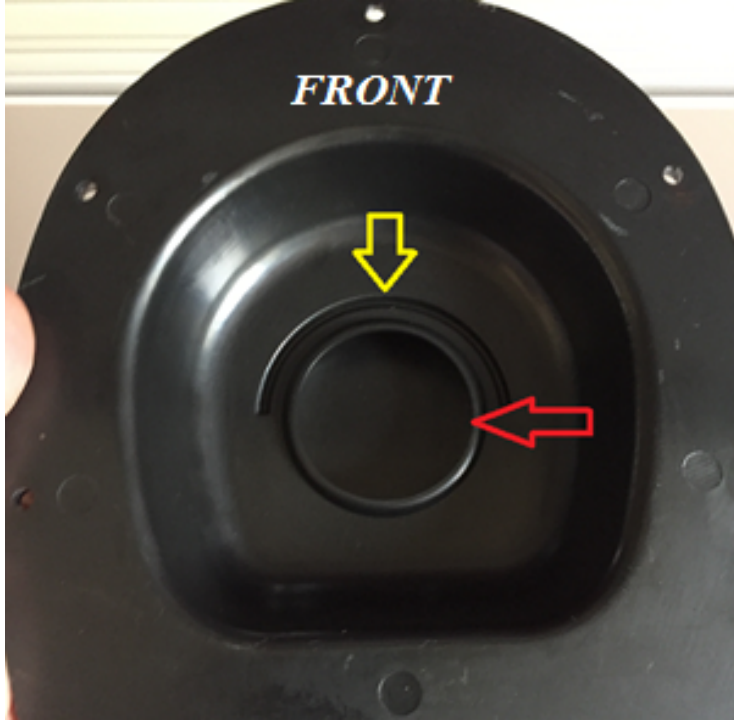
FIGURE #4

As you can observe in Figure #4 the 2" hole is indicated by the red arrow. There is also an indent in the plastic shown with the yellow arrow which is where there is a rubber "diverter" to the front of the vent. This is designed to channel water away from the hole while the bus is in a forward motion. This is VERY helpful from the initial design, but when there are "driving" rains with wind "pushing" water in every direction we know water will infiltrate even the smallest openings and that is not a small opening.

Seeing as most units built for New York State have roof hatches and some roof hatches that Blue Bird and Microbird offer have static vents built into them, we started to question how we could address that 2” hole (Figure #4).

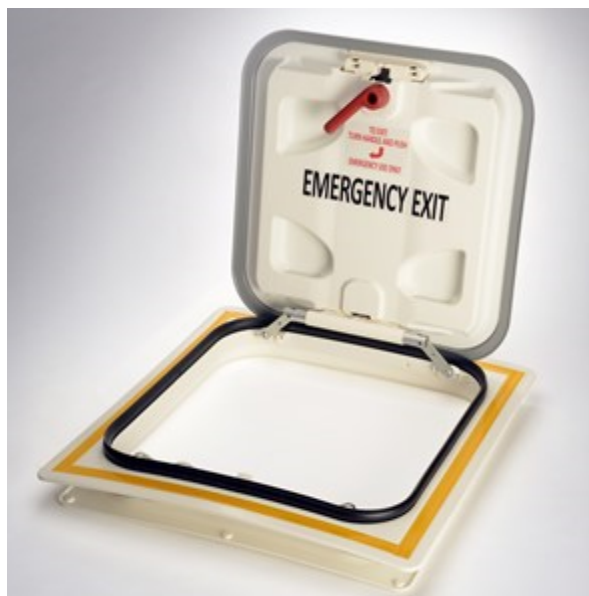
FIGURE #8

If units were NOT built with the “vented” roof hatches it is possible to change the existing hatches to the vented design. If you have a “standard hatch” with no vent you have the choice between the Spheros “SMART” hatch (Figure #8) and the Safe Fleet “Triple Value” (Figure #9).
