Sleeping Child Check Feature #BUS-6 & #BUS-6T Sales Update #17-04

Doran “Sleeping Child Check” in a Microbird

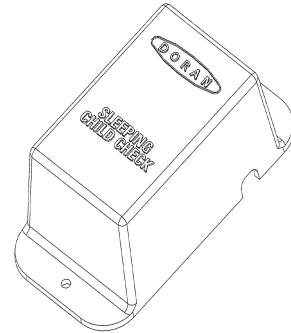
A customer recently asked why after warming their units for pre-trip, that the child-check alarm would sound.

The Microbird’s were built with #BUS-6 (a New York Bus Sales standard feature) with the Doran Sleeping Child Check. That system would arm when the warning lights were activated as was intended. However, the listing of the feature failed to include that the system would ALSO arm after the unit had run for 10 minutes, thus causing the issue which these customers were experiencing. There is a feature #BUS-6T which is wired so ONLY the warning lights are the system.

If you have a unit with feature #BUS-6 and you do not wish to have the time active, there is a way to disable it. On the plug for the module you will find a red wire, which jumps from pin #5 to pin #14 on the plug. If you remove this wire, it will deactivate the timer. Below is a schematic of the module plug.
