Defroster Air Loss to R.H Windshield 2012 and Newer Body Tech Tip #16-1207

Does your BBCV (Vision) defroster have more pressure on the driver side than the passenger side?

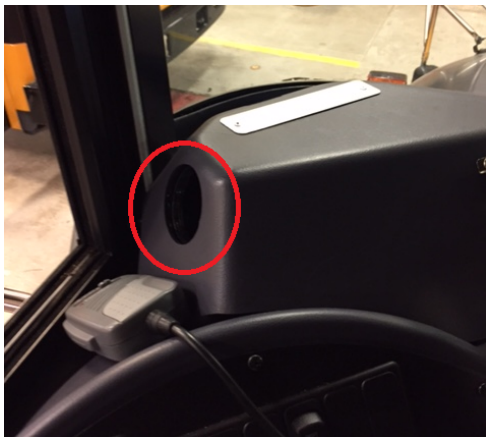
Figure #1

To better see this you can remove the driver’s window duct (Figure #1) and look toward the windshield and see the end of the deflector (Figure #2).

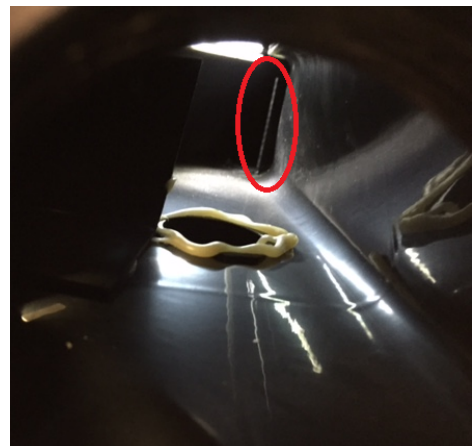
Figure #2

Blue Bird said they had found that there was a “deflector” which runs along the length of the defroster duct molded into the dashboard. In instances where air was not making it to the passenger side windshield the deflector had come loose and was blocking air flow.
