Side Emergency Door / Luggage Door Obstruction Tech Tip #15-1001REVA

We are addressing concerns associated with luggage doors obstructing the side emergency door operation. By using a cable to limit travel to 90° the luggage door cannot obstruct the side emergency door operation. Below, we have updated Tech Tip #15-1001 and our resolution to the issue with what we feel is a more robust and positive hold back for the luggage door.

Side Emergency Door-Luggage Door Obstruction

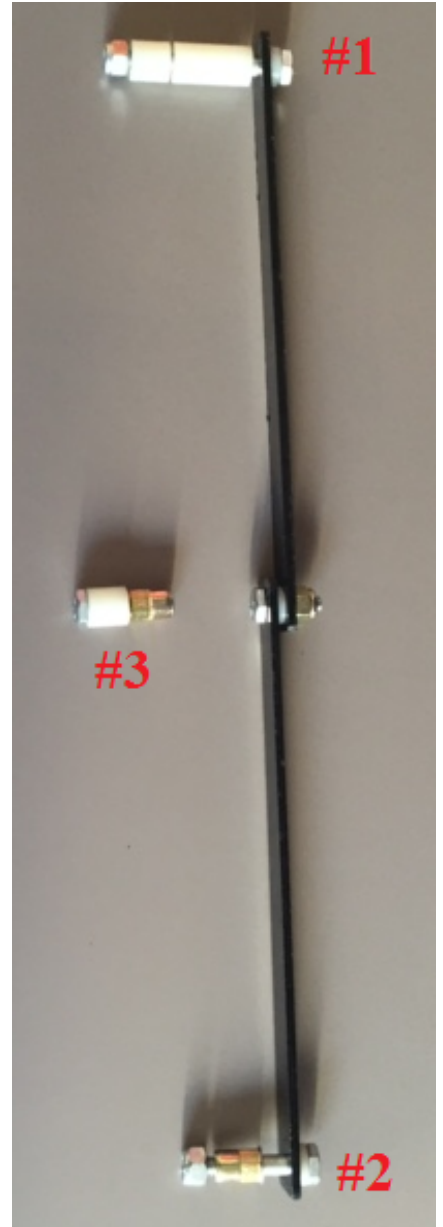
The unit comes assembled as in the photo below on the left. Removing the tape there is a nut sert , plastic bushing and ¼ X 1 (STOP) bolt separate from the assy. #3 in the photo below on the right.

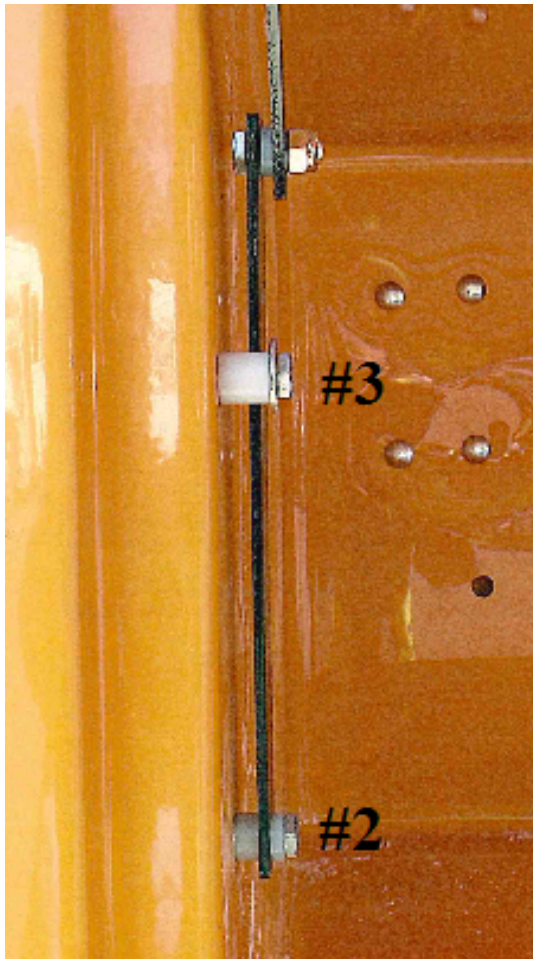
Step #3 – Install the lower pivot bolt with the nylon washer between the arm and the nut sert, Tighten so that the arm moves freely on the bolt, but is not sloppy and then install the locknut in the bolt on the outside of the box to avoid having the bolt back out. Item #2 in the photo to the left below.

Step #4 – Install the “stop” in the upper nut sert with the nylon spacer as shown at #3 in the photo to the left below.

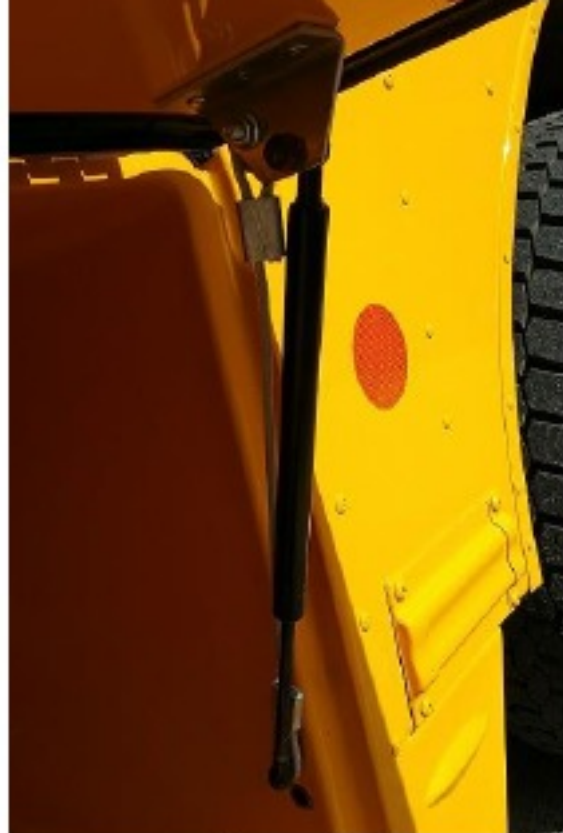
Figure #1

Below Figures #1 & #2 show the strut which holds the luggage doors open on our fiberglass luggage. As you can see we have added a cable to limit the travel by wrapping the cable around the lower pivot of the strut and then using one of the bolt holes in the door bracket and a fender washer. Limiting the the travel assures the luggage door does not travel the full stroke and obstruct the side emergency door, see Figures #3 & #4

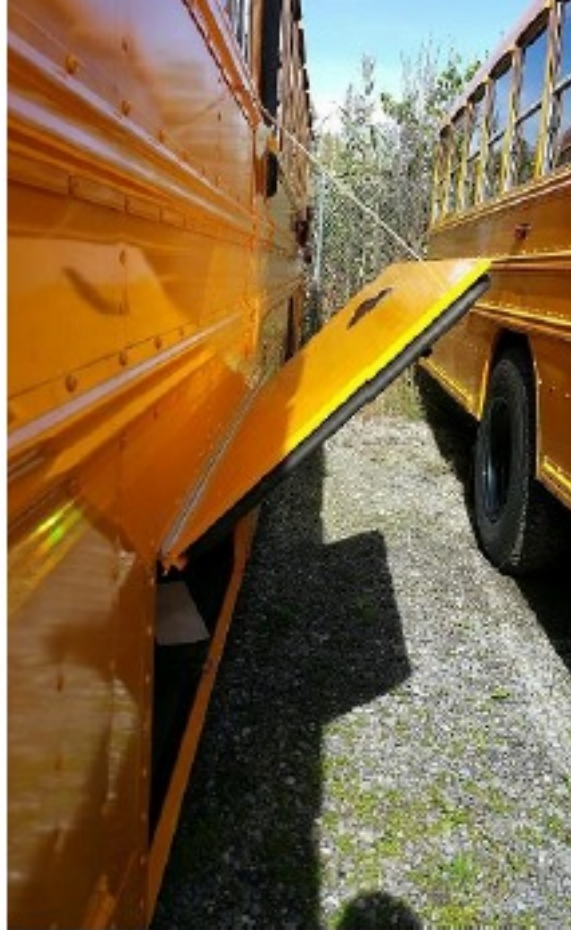
Figure #5 below shows the luggage door on a Rear Engine unit as presented from Blue Bird, their doors are held open by a cable attached to the door and a holder mounted on the body. Making a longer cable will allow the door when opened to be adjusted so it does not obstruct the side emergency door, see Figure #6
