14-0911-1 – Battery Stud

Product Affected – Chassis Mounted Battery Box Stud

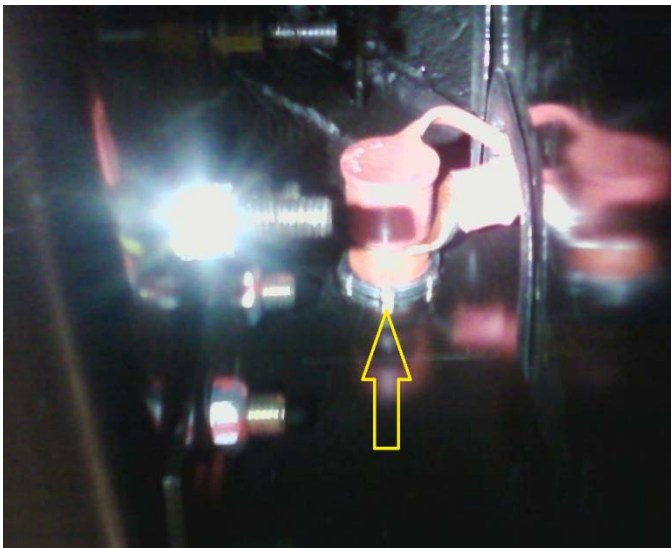
Fig 1

- Correction:** Figure #1 shows the stud mounted to the battery box and the spanner nut holding the stud to the box. Figure #2 shows the stud to the rear of the box. One thing we found is the spanner nut is located in such a position that it is difficult to get a spanner wrench or socket on it. If you disconnect the batteries, remove the cables and then remove the stud and re-install 180* so that the spanner nut is located to the rear you can get a better “grip” on it with your spanner wrench or socket. Adding a drop of Loctite will help ensure the stud will not loosen from future movement of the cables. See figures #3 and #4-
