## 14-0911-1 – Battery Stud

### Product Affected – Chassis Mounted Battery Box Stud

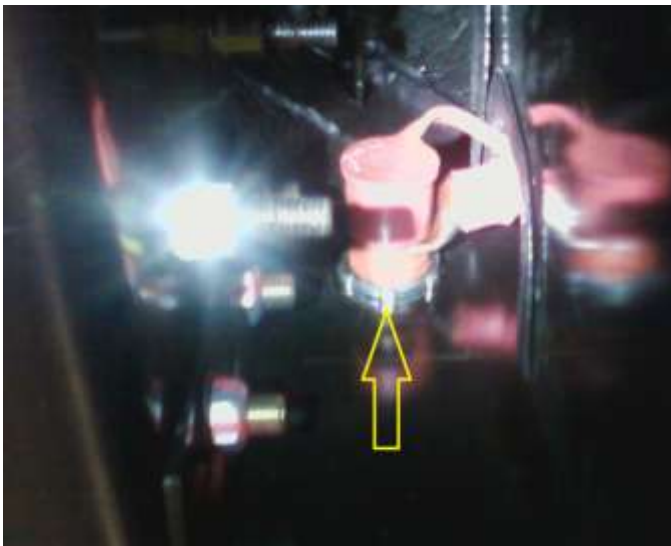
Fig 1

- Correction:** Figure #1 shows the stud mounted to the battery box and the spanner nut holding the stud to the box. Figure #2 shows the stud to the rear of the box. One thing we found is the spanner nut is located in such a position that it is difficult to get a spanner wrench or socket on it. If you disconnect the batteries, remove the cables and then remove the stud and re-install 180\* so that the spanner nut is located to the rear you can get a better “grip” on it with your spanner wrench or socket. Adding a drop of Loctite will help ensure the stud will not loosen from future movement of the cables. See figures #3 and #4-

- Complaint:** When servicing the batteries, the power cable is “loose” where the cable goes through the back of the battery box.
- Cause:** There is a power stud mounted behind the battery box and with the battery tray moving in and out the pulling on the cable loosens the stud.
