# Rear Wall Heater Motor Fused Circuit Protection

# BULLETIN

**Models Affected: The following models equipped with rear wall heaters**  
**2004-2009 Model Year All American and Vision Model Buses**  
**2004-2008 Model Year Conventional Model Buses**

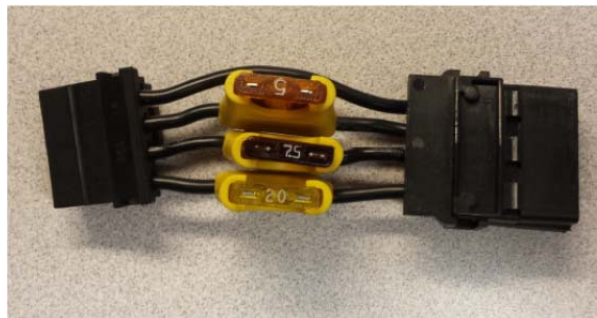
Jumper Harness

1. Before performing service bulletin, verify all rear wall heater blower motor speeds operate correctly and repair if necessary.
2. Park the bus on a level surface, apply parking brakes, turn off engine and remove ignition key. Chock wheels
3. Identify quantity of rear wall heater motors on bus affected by service bulletin.
4. One (1) rear wall heater jumper harness (Part Number: 1000662031) is required for each rear wall heater motor.

Add jumper harness (Part Number: 1000662031) with individual circuit fuse protection for both low and high speed circuits of each rear wall heater blower motor.

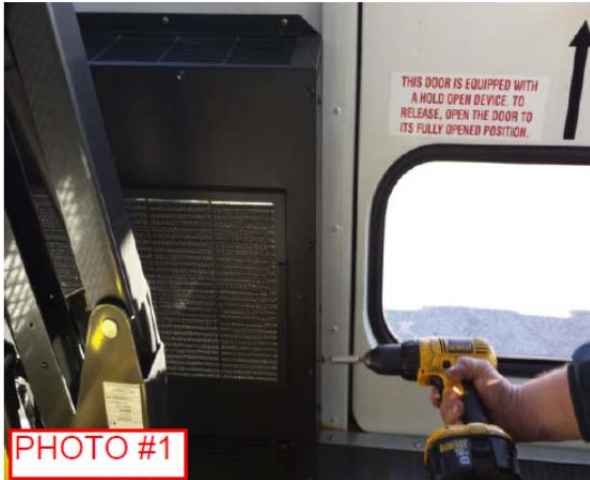
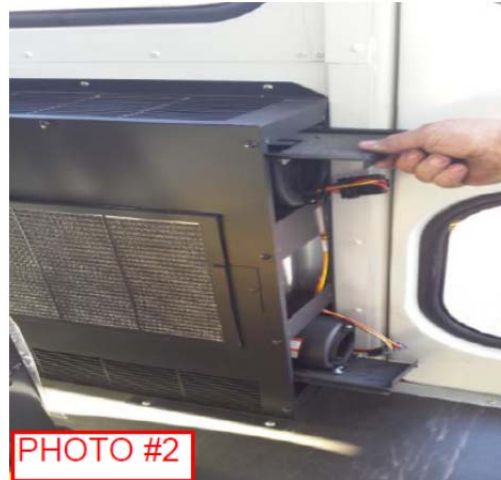
5. Remove ten (10) Phillips screws and end cover from rear wall heater. Slide blower motor assemblies out to access the four pin connector on each motor.  
(See photo 1 & 2)

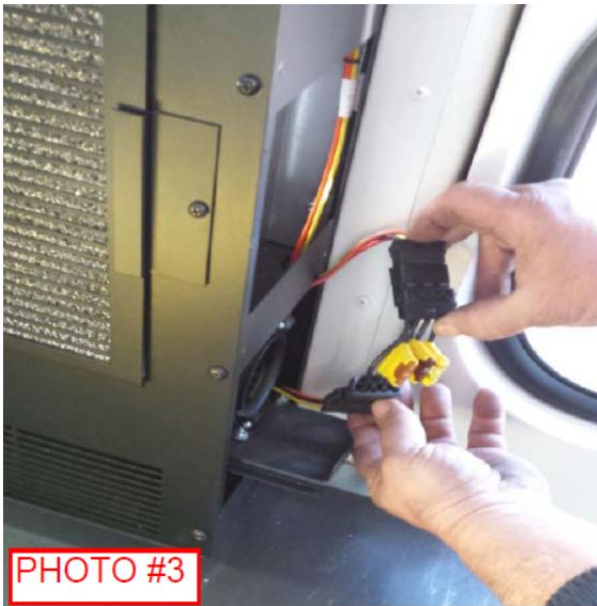
6. Unplug one rear wall heater motor connector at a time and install jumper harness in series.  
(See photo 3) Repeat this step for each rear wall heater motor harness.

7. Slide blower motor assemblies back in and install end cover with ten (10) Phillips screws.
8. After jumper harness installation, verify both low and high rear wall heater blower speeds operate.
9. If either blower speed fails to operate verify jumper harness fuse is installed, not blown (open). Contact your Blue Bird dealer if you require any assistance.
