Tech Tip 15-0303-1

MicroBird G5 Rear Interior Panels

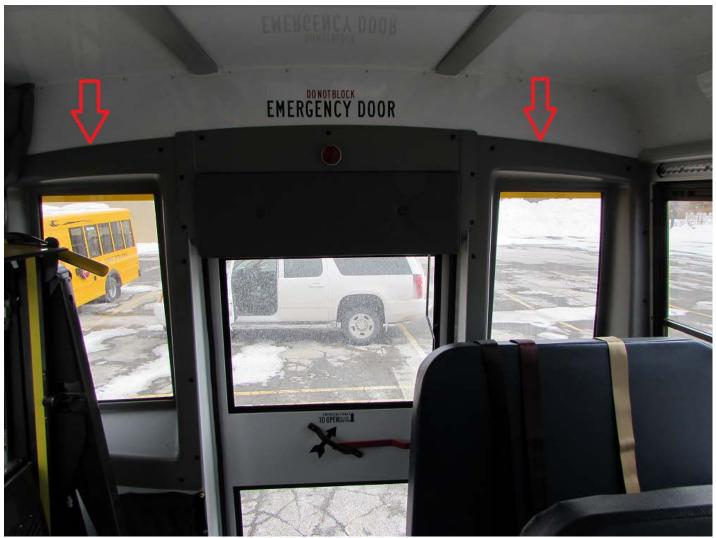
Figure 1

There have been instances where the plastic trim panels around the rear windows (Figure 1) cracked. There was concern these were structural panels and once they cracked the unit needed to be taken out of service. Attached is a letter from Microbird which clearly states these are not structural and are for aesthetic purposes only.

It has been brought to our attention that, in a routine inspection, a New-York DOT inspector has found a crack in the thermo plastic part surrounding the rear glass next to the emergency door. The following question was then raised: "Does this part have any structural purpose?"

In fact, it doesn't. This is what we call an esthetic trim to enhance the interior appearance of the bus which, at the same time, prevents exposure to sharp edges behind the trim for the occupants. In addition to fixing these trims with rivets, they are glued all around to the different panels with joint strength glue. It means that, even if this thermo plastic part has a crack, it will neither compromise the structural integrity of the bus nor jeopardize the safety of the passengers.
