Tech Tip

From your friends at New York Bus Sales

Complaint - The bleeder valve located below the fuel fill seems to be leaking pre-maturely (Figure #1)

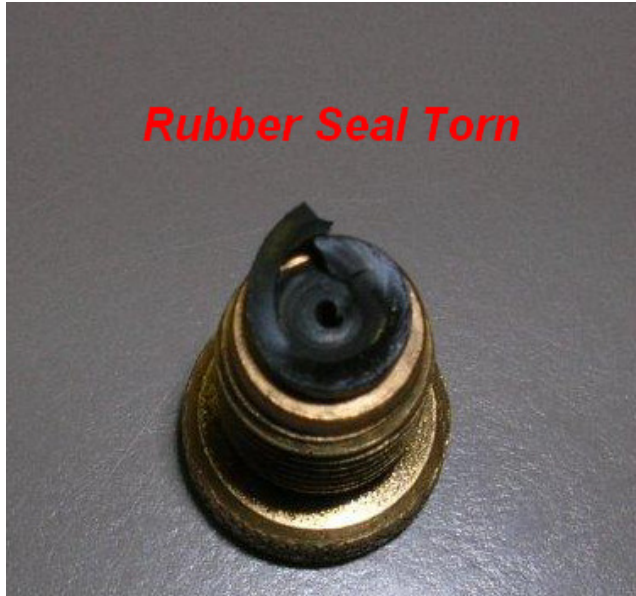
Cause - The person filling the unit maybe trying to tighten the bleeder too much which causes tearing of the bleeder seal (Figure #4)

Rubber Seal Torn
