# Tech Tip

*From your friends at New York Bus Sales*

**Complaint -** Drivability – Unit stumbles and in a severe instance unit will quit. May cause a hard or extended start.

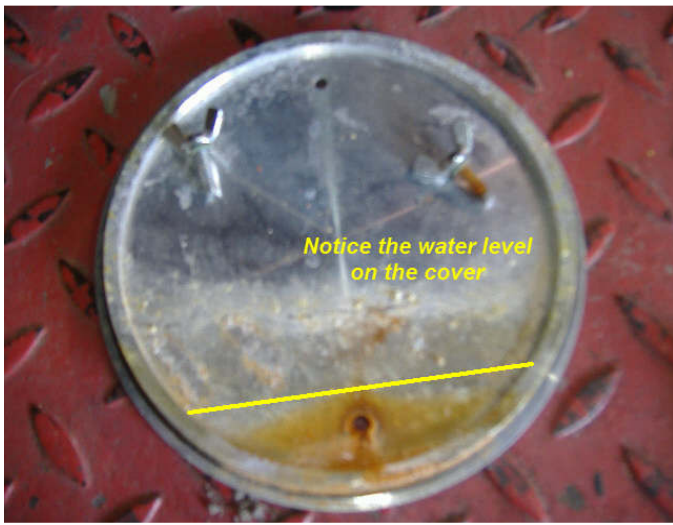
**Figure #1**

- Remove the cover from the multi-valve locate in the right rear fuel tank....you will notice from the evident water that may run out and the signs of a water line as in Figure #2 that this may be the issue (Figure #1)

- Locate the fuel supply solenoid (Figure #1)
- Remove the “E” clip and washer (Figures #3 &4) from the Solenoid and inspect the solenoid as well as the solenoid stud base – Notice corrosion (Figure #5)
