From your friends at New York Bus Sales

Complaint - Bus was designed not to start when the fuel door is opened but when we were checking it noticed that it did start when the door was open.

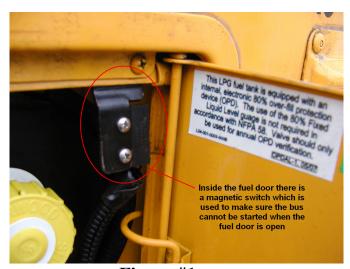
Correction - If you look at Figure #1 you can see the switch located in the fuel fill compartment. Looking further in Figure #2 you can see where the magnet has rolled down to the bottom of the fuel door and is resting on the lip of the door.

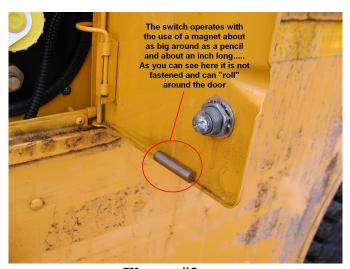
Figure #2

Cause - The magnet on the fuel door used to operate the switch has moved away from its intended position.

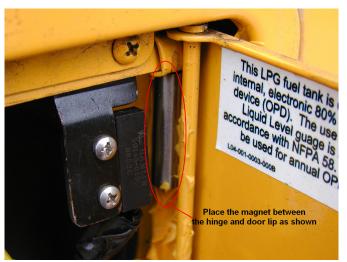
Adding some silicone to the frame of the opening as in Figure #3 and placing the magnet in the silicone as in Figure #4 and letting it sit and dry will assure the magnet will not "roll" from its position.

PLEASE NOTE: It is recommended that the switch operation be checked at each PM.
